***Flight Control Restrictions
Due to Deicing/Anti-icing
Fluid Residues***

**A Large Aircraft Manufacturer's
Perspective**

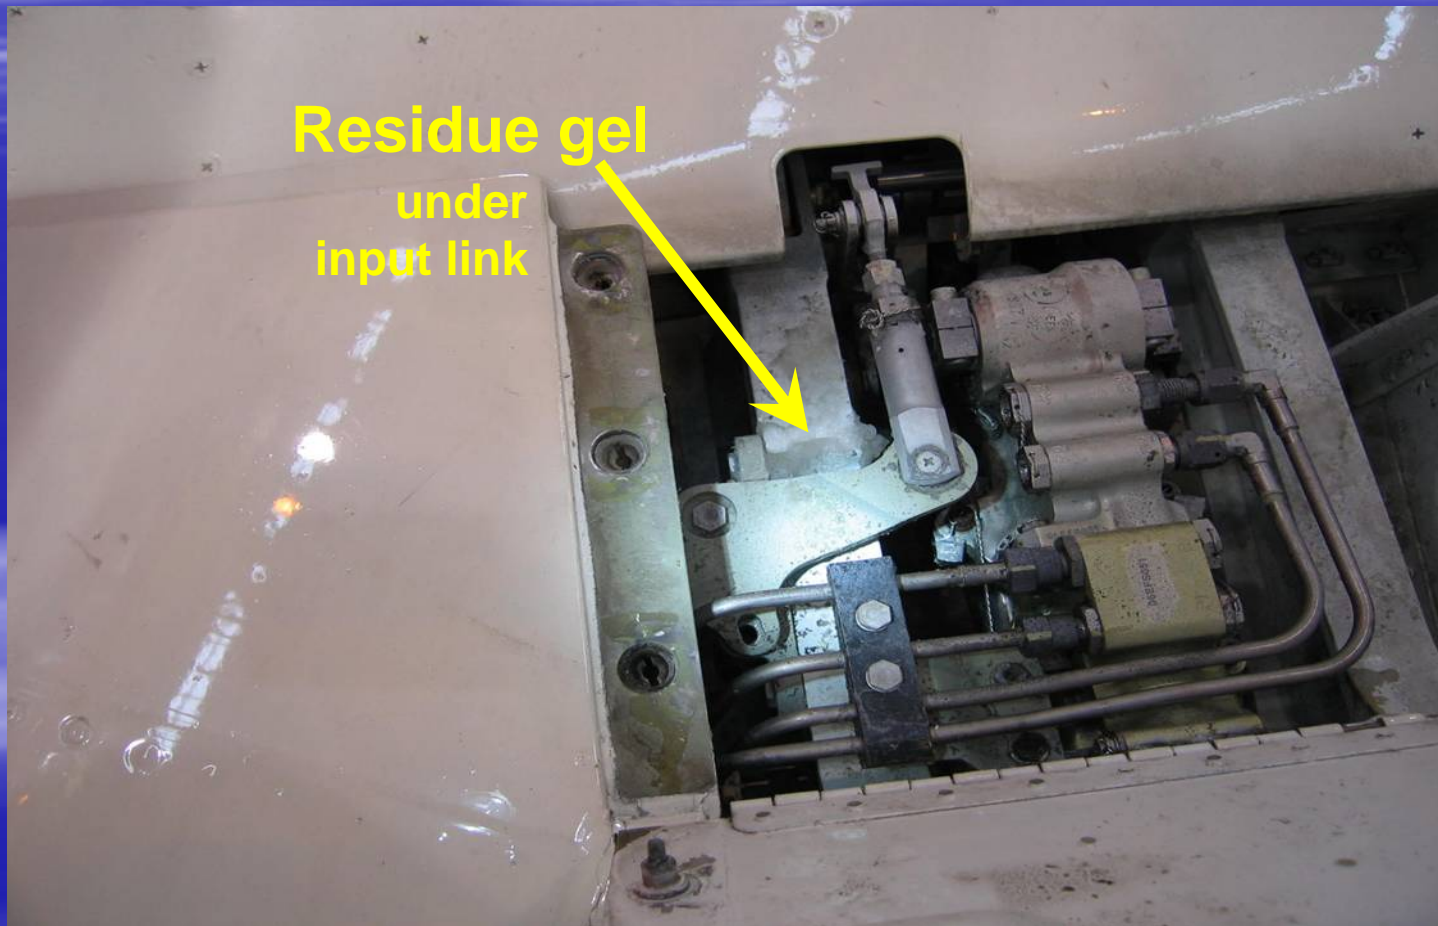
- MD-90 Elevator PCU Input Linkage

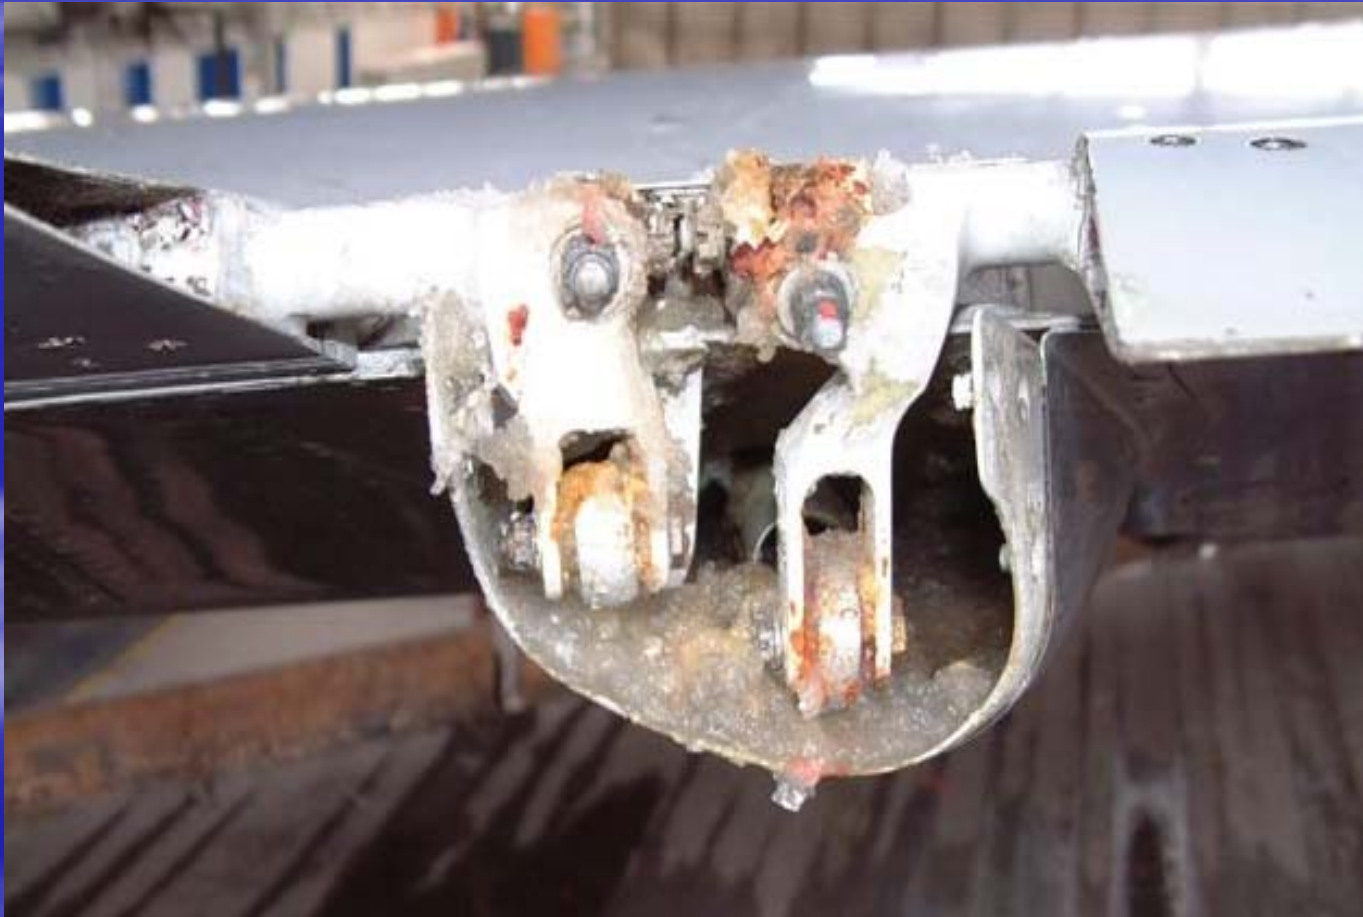
- MD-90 Elevator Tab Control Rods

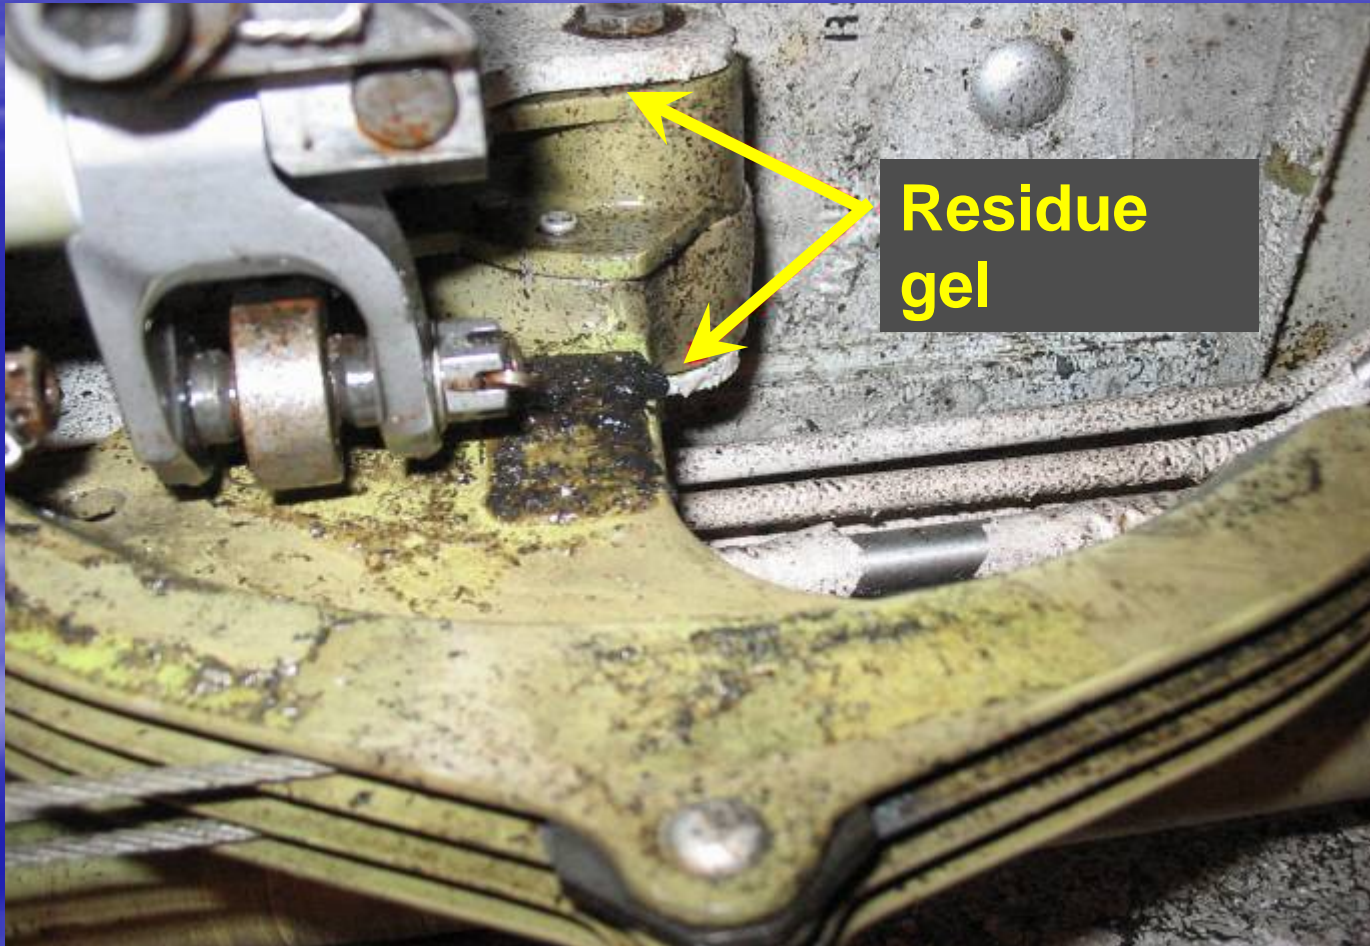
- 737-300 Flight Spoiler PCU Input Quadrant

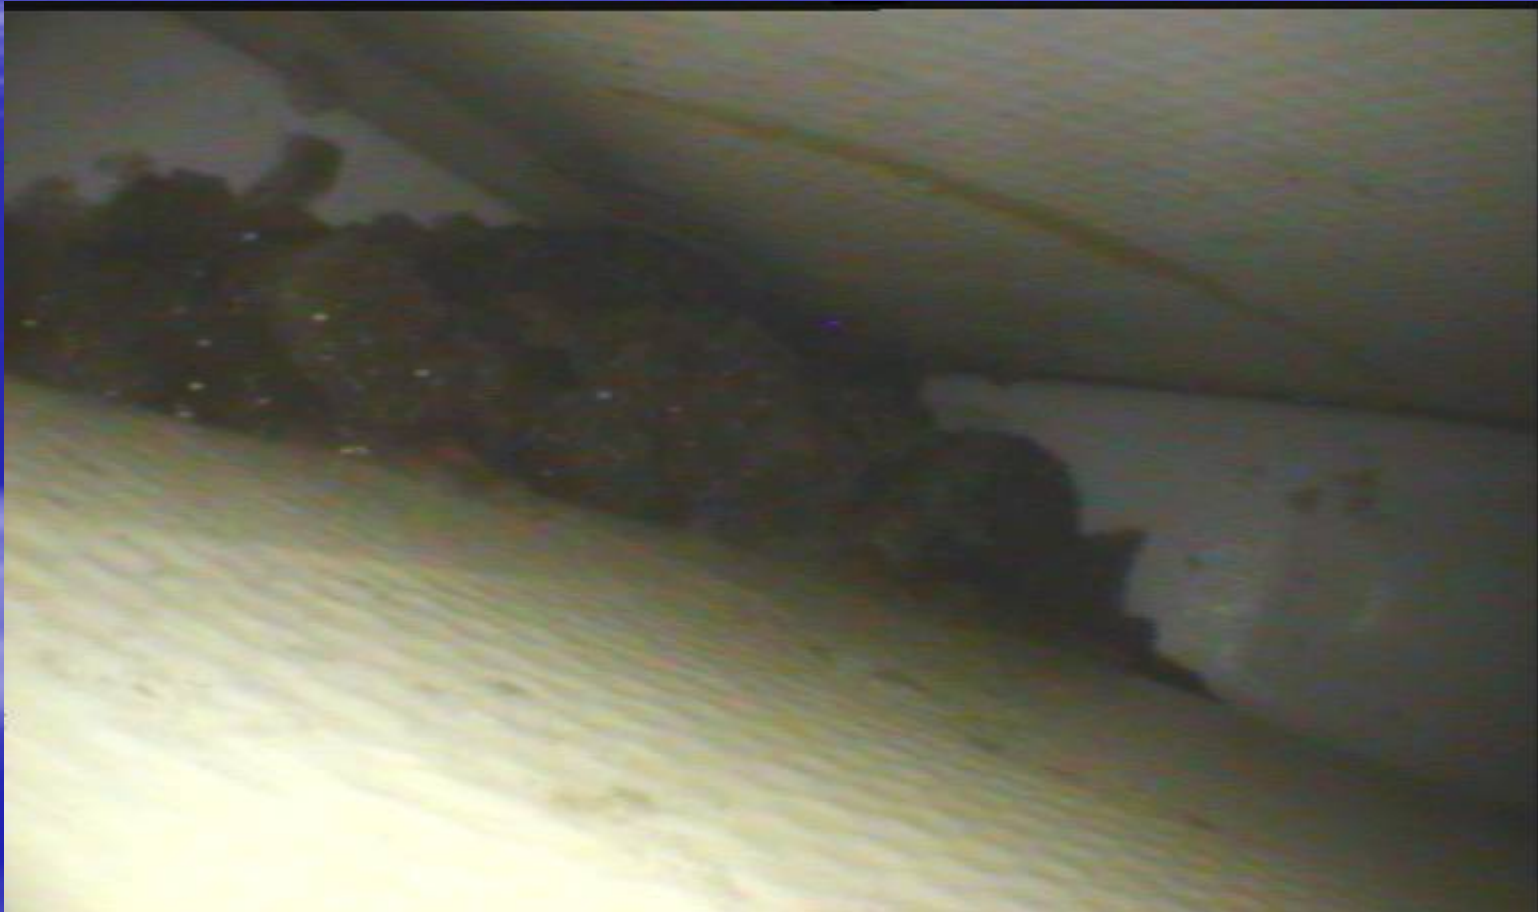
- 737-400 “Inside” Elevator Control Surface

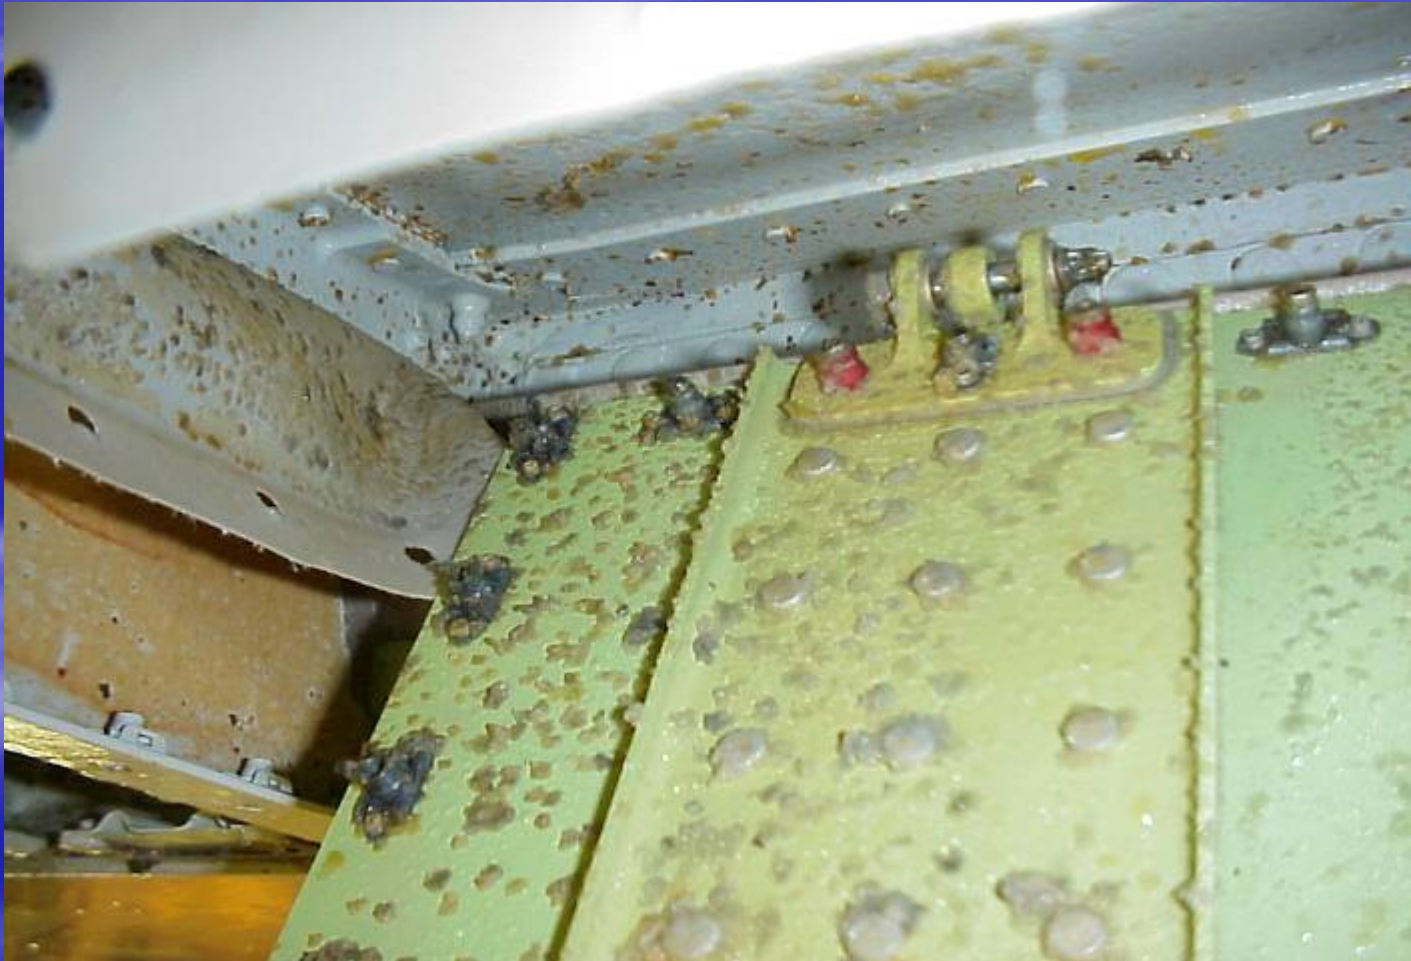
- 737-600 Elevator Balance Panel

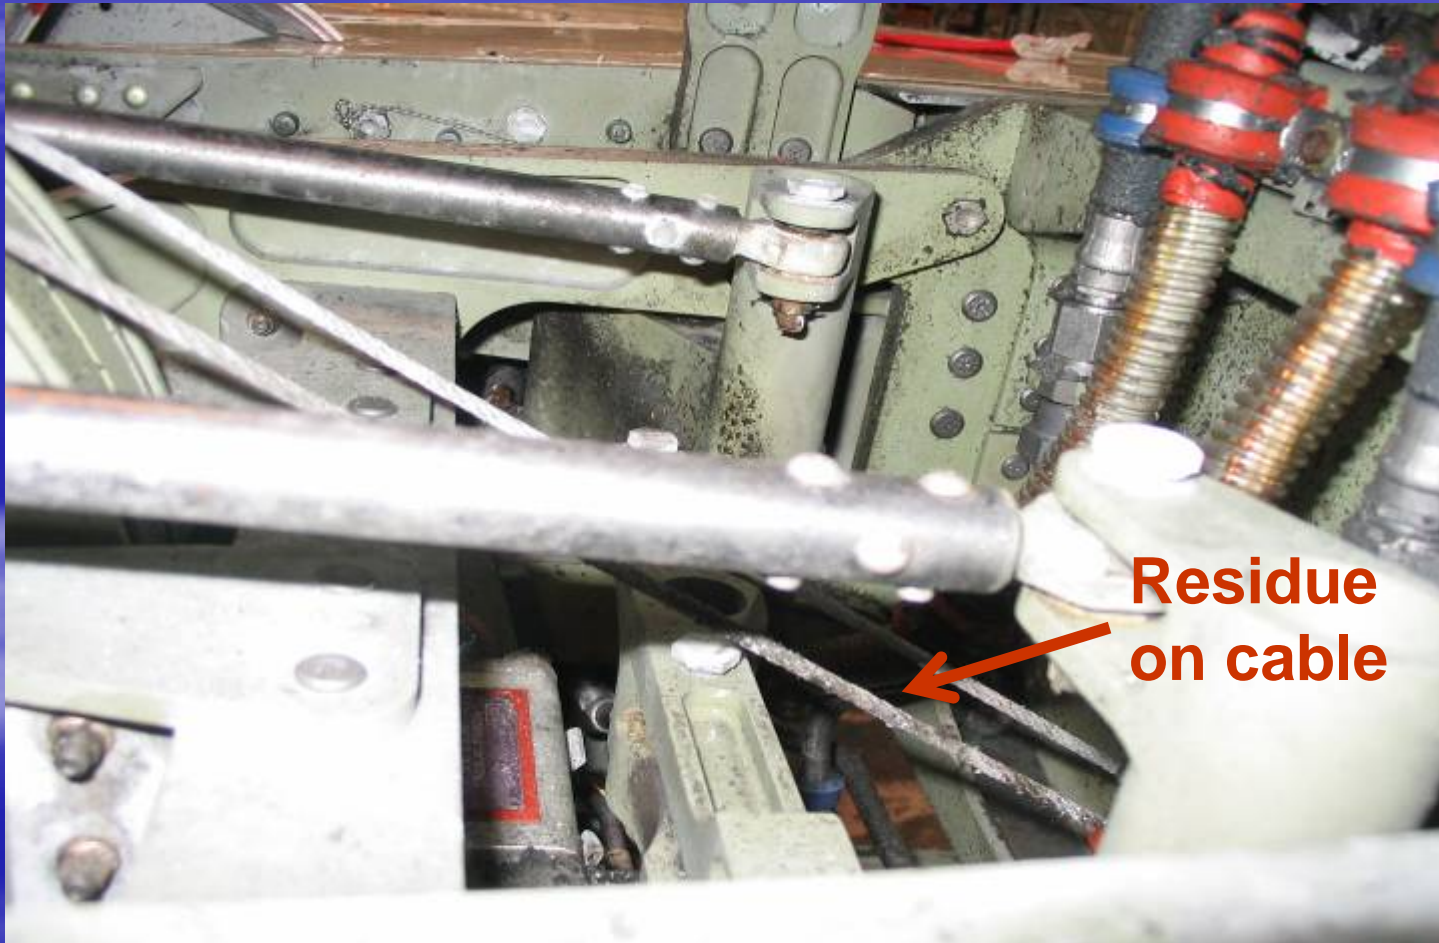
- MD-90 Junction of Vertical & Horizontal Stab

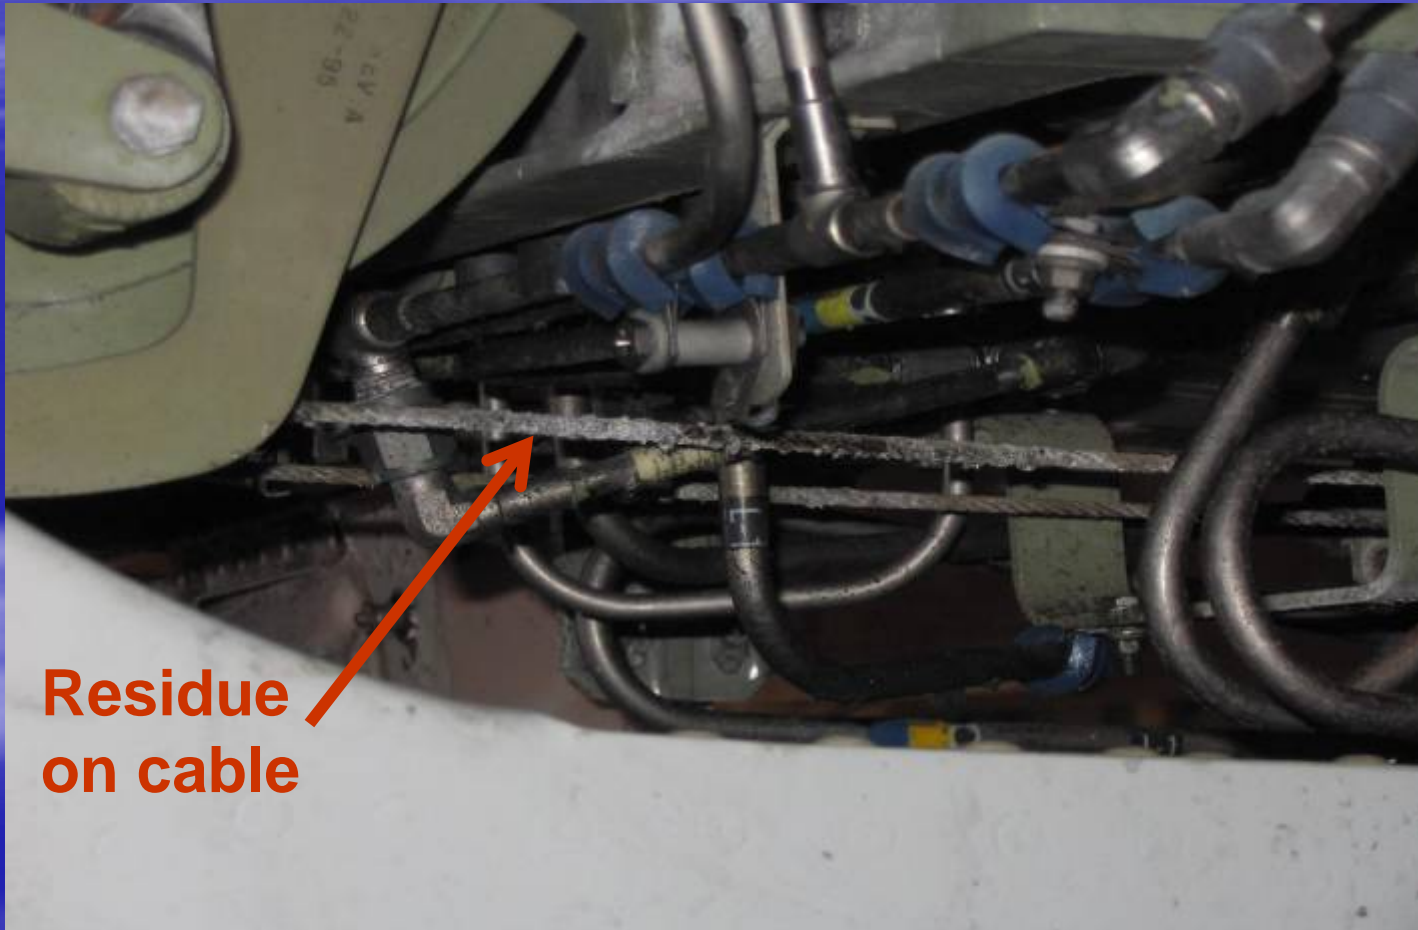
- MD-90 Junction of Vertical & Horizontal Stab

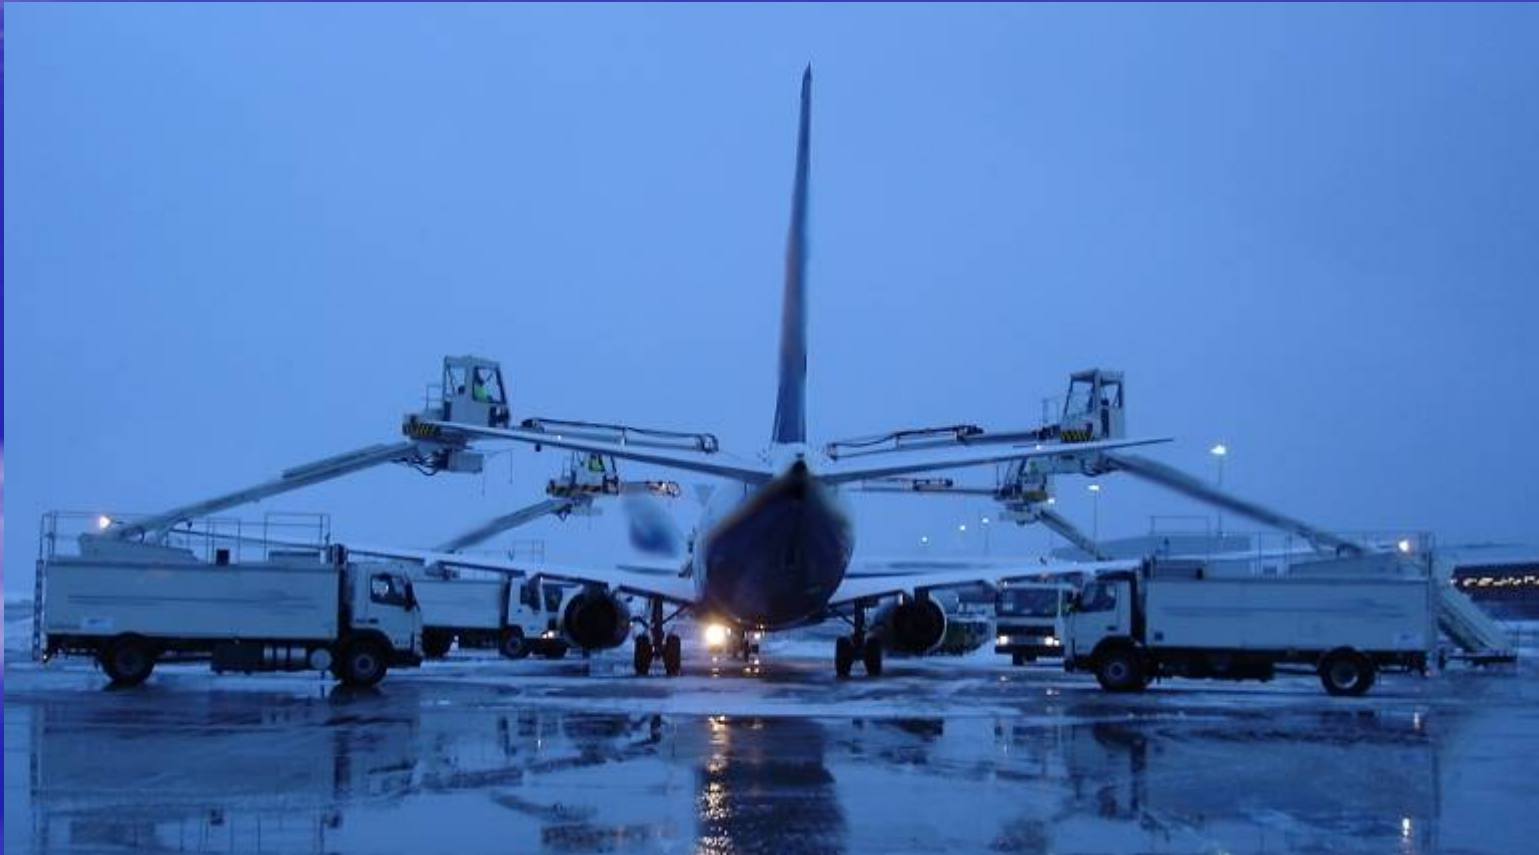
- Large volumes of fluid can be used during severe weather
