# **The Continuing Threat to Aviation Safety from Aircraft Icing**

**A Review of Recent NTSB Accident and Incident Investigations**

Daniel R. Bower, Ph.D.

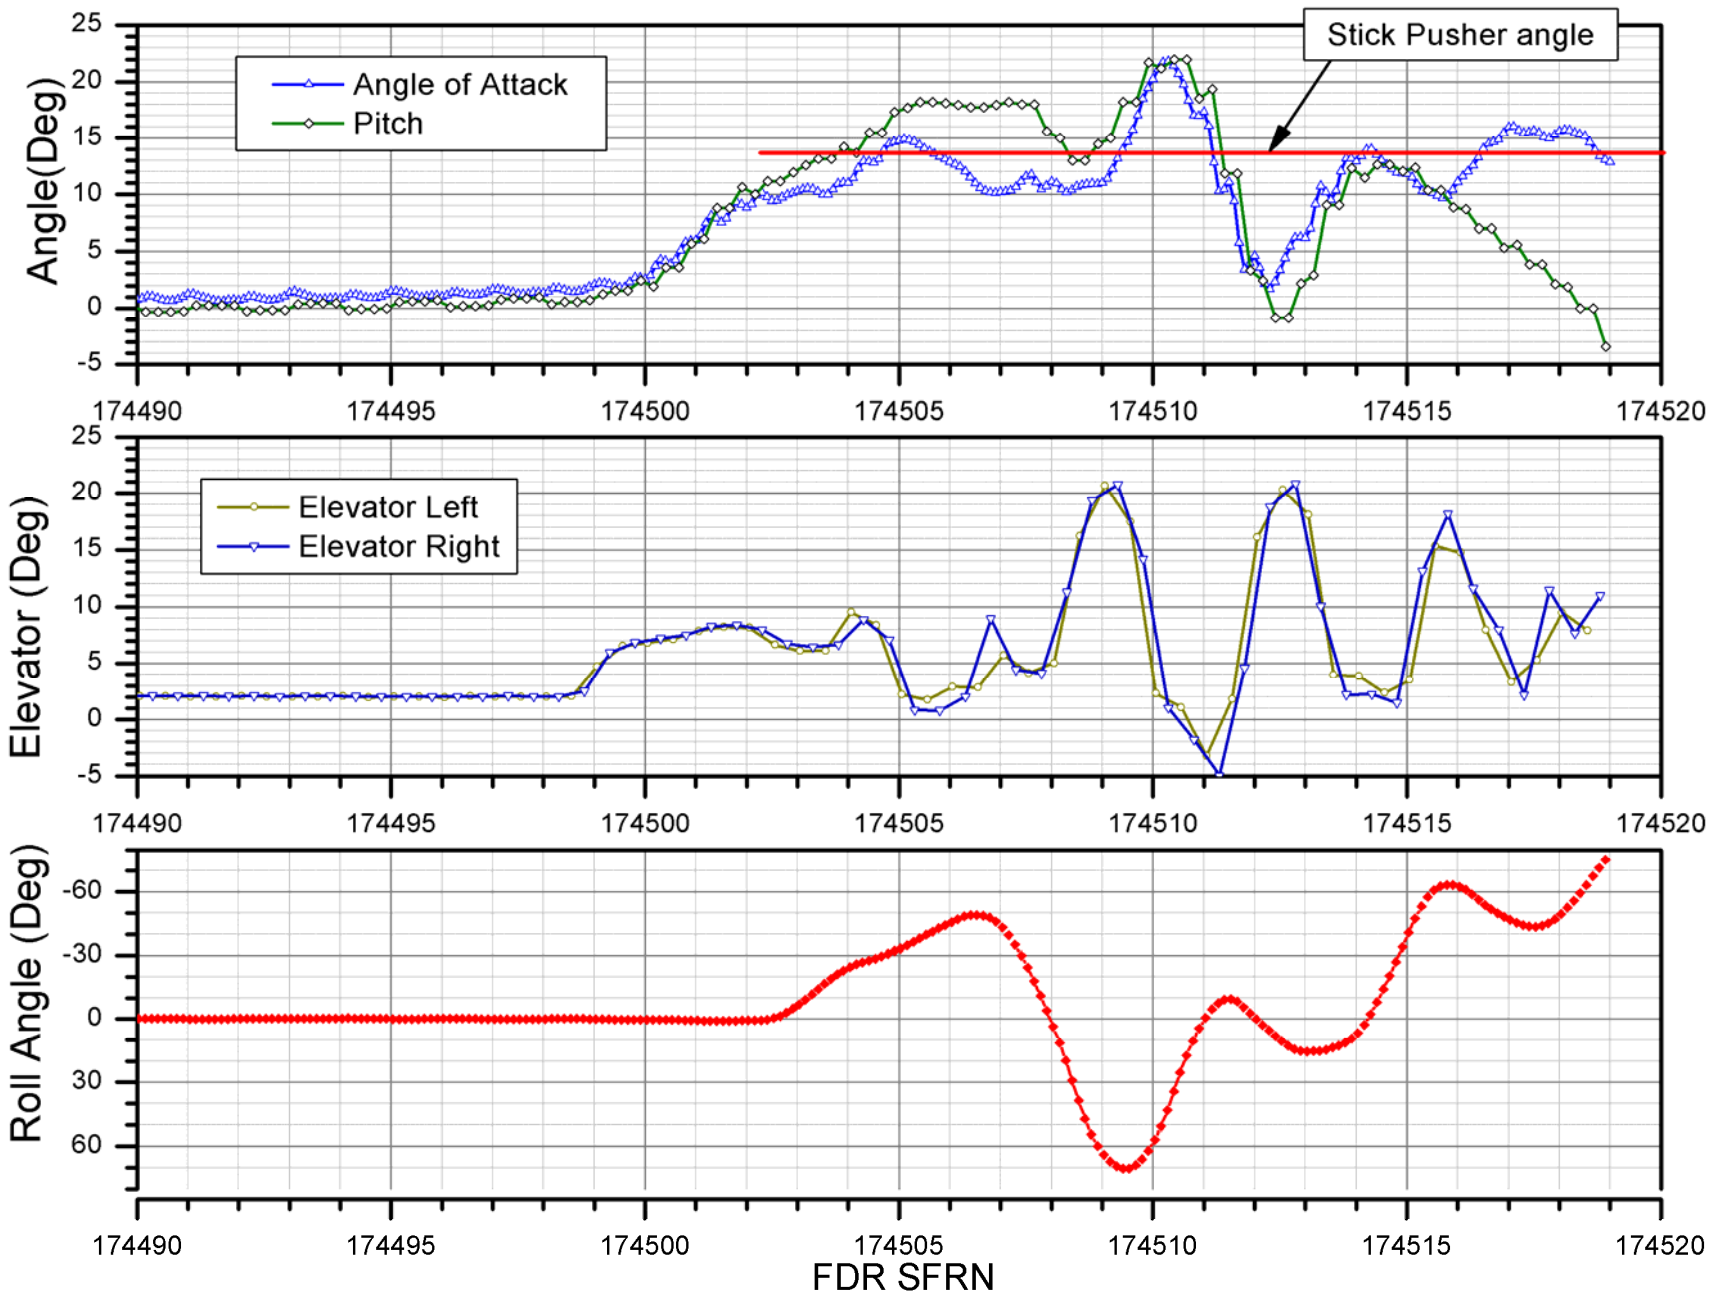
# Accident Flight

- Rolled past 50 deg left shortly after TO
- Followed by a 70-deg roll to the right
- Bank angles less than 20 deg for about 4 sec
- Final roll to the left
- Never exceeded 180 ft agl
- Wheel opposed roll maneuvers

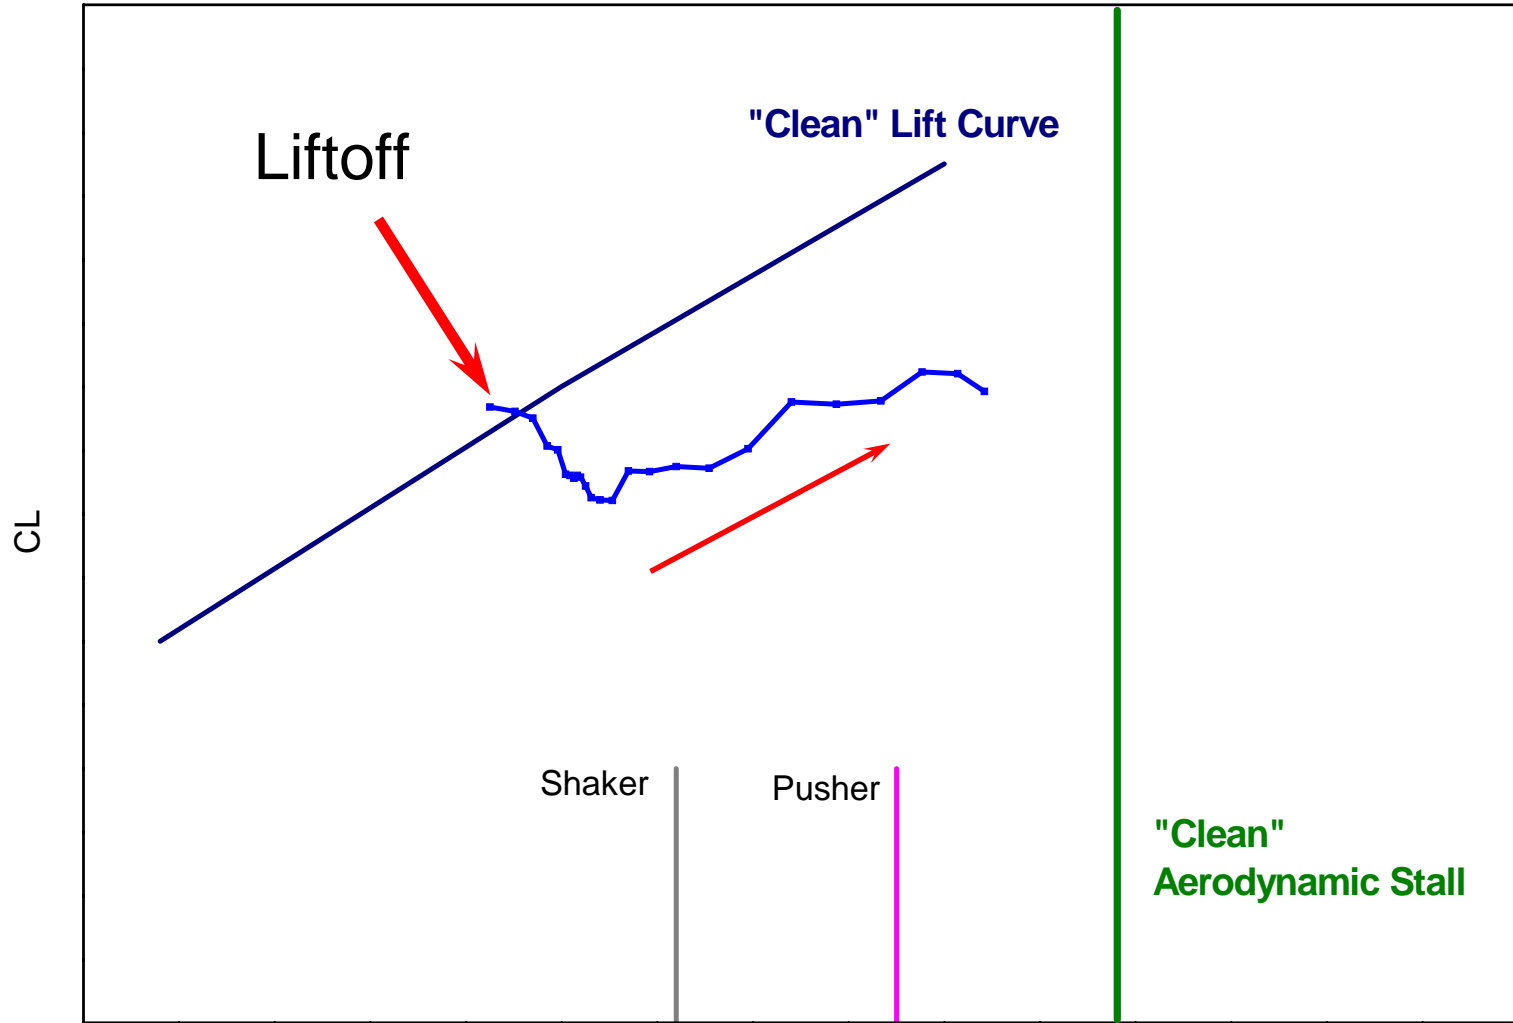
China East Airlines  
0-5 seconds after liftoff

- Kinematics extraction simulation tool
  - Compares aerodynamics required for motion with aerodynamics from simulation model using recorded control input and state

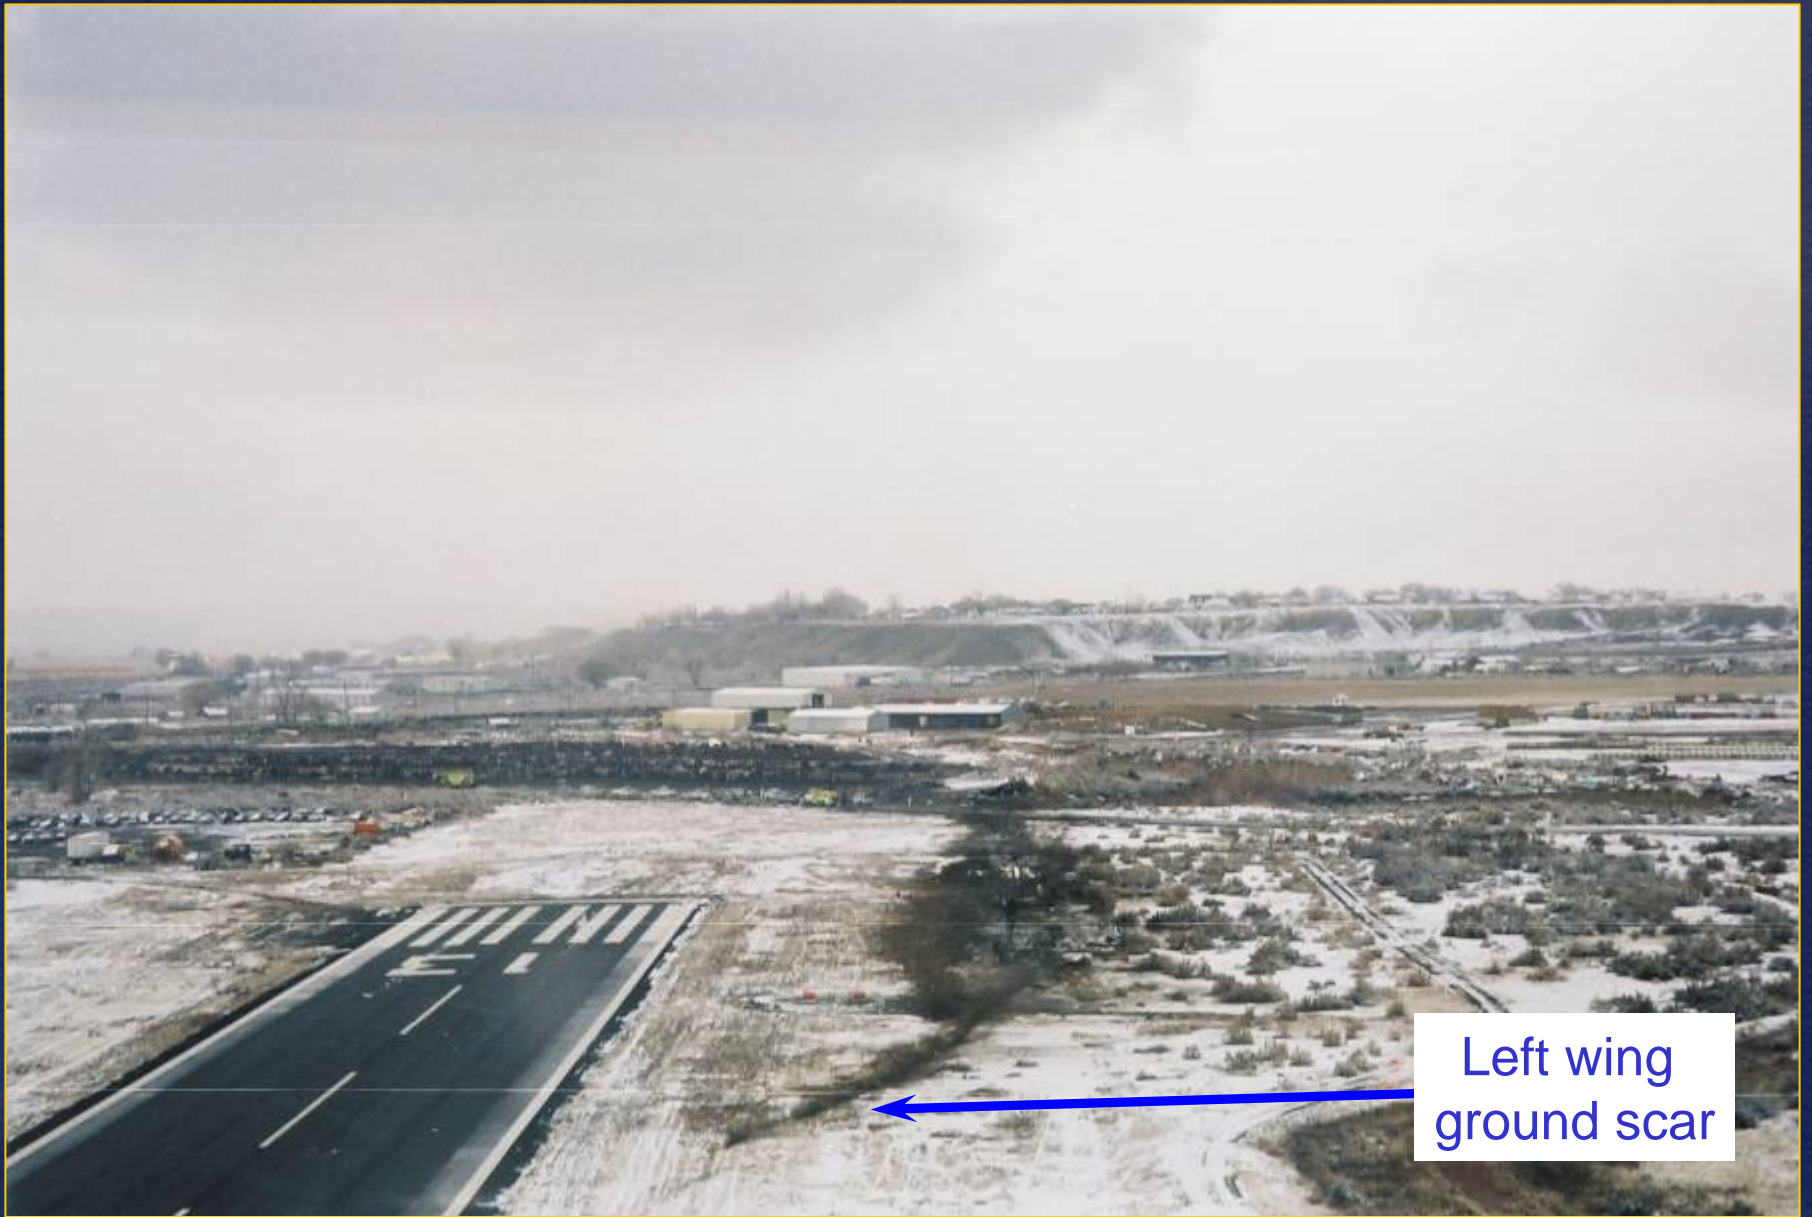
Left wing  
ground scar

- Slushy clumps of snow sliding across window
- Airplane lifted off and climbed about 20 to 50 feet
- Left wing dropped abruptly, then right wing dropped, followed again by left wing
- Passenger heard loud thump and airplane fell straight onto its nose

“The flight crew's failure to ensure that the airplane's wings were free of ice or snow contamination that accumulated while the airplane was on the ground, which resulted in an attempted takeoff with upper wing contamination that induced the subsequent stall and collision with the ground...”

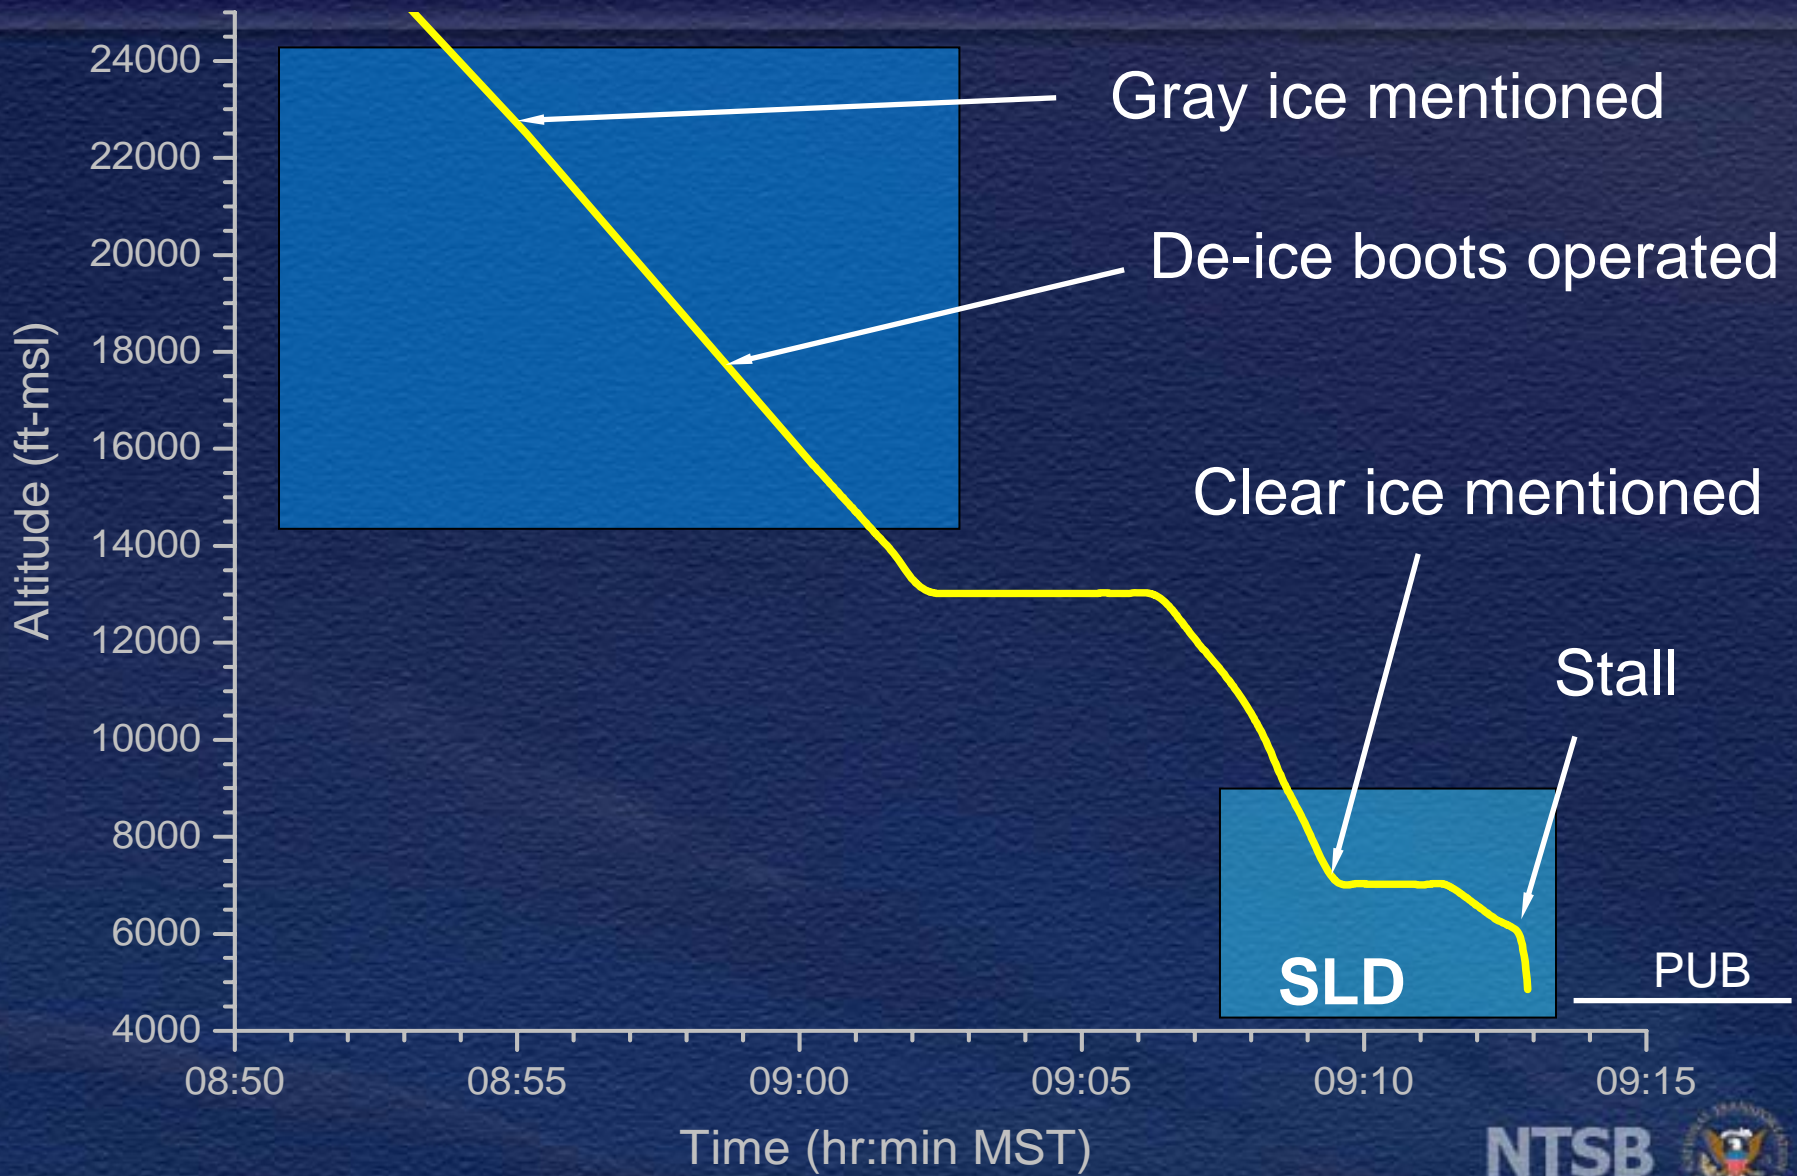
# Altitude Time History

- Airplane slowed below  $V_{approach}$
- De-ice boots not operated in second icing layer
- Presence of estimated 1/6 inch or less of ice accreted in SLD conditions caused airplane to stall prior to stick shaker
- Airplane entered a rapid left roll prior to stall warning
- Airplane did not recover in the 1,500 feet agl available

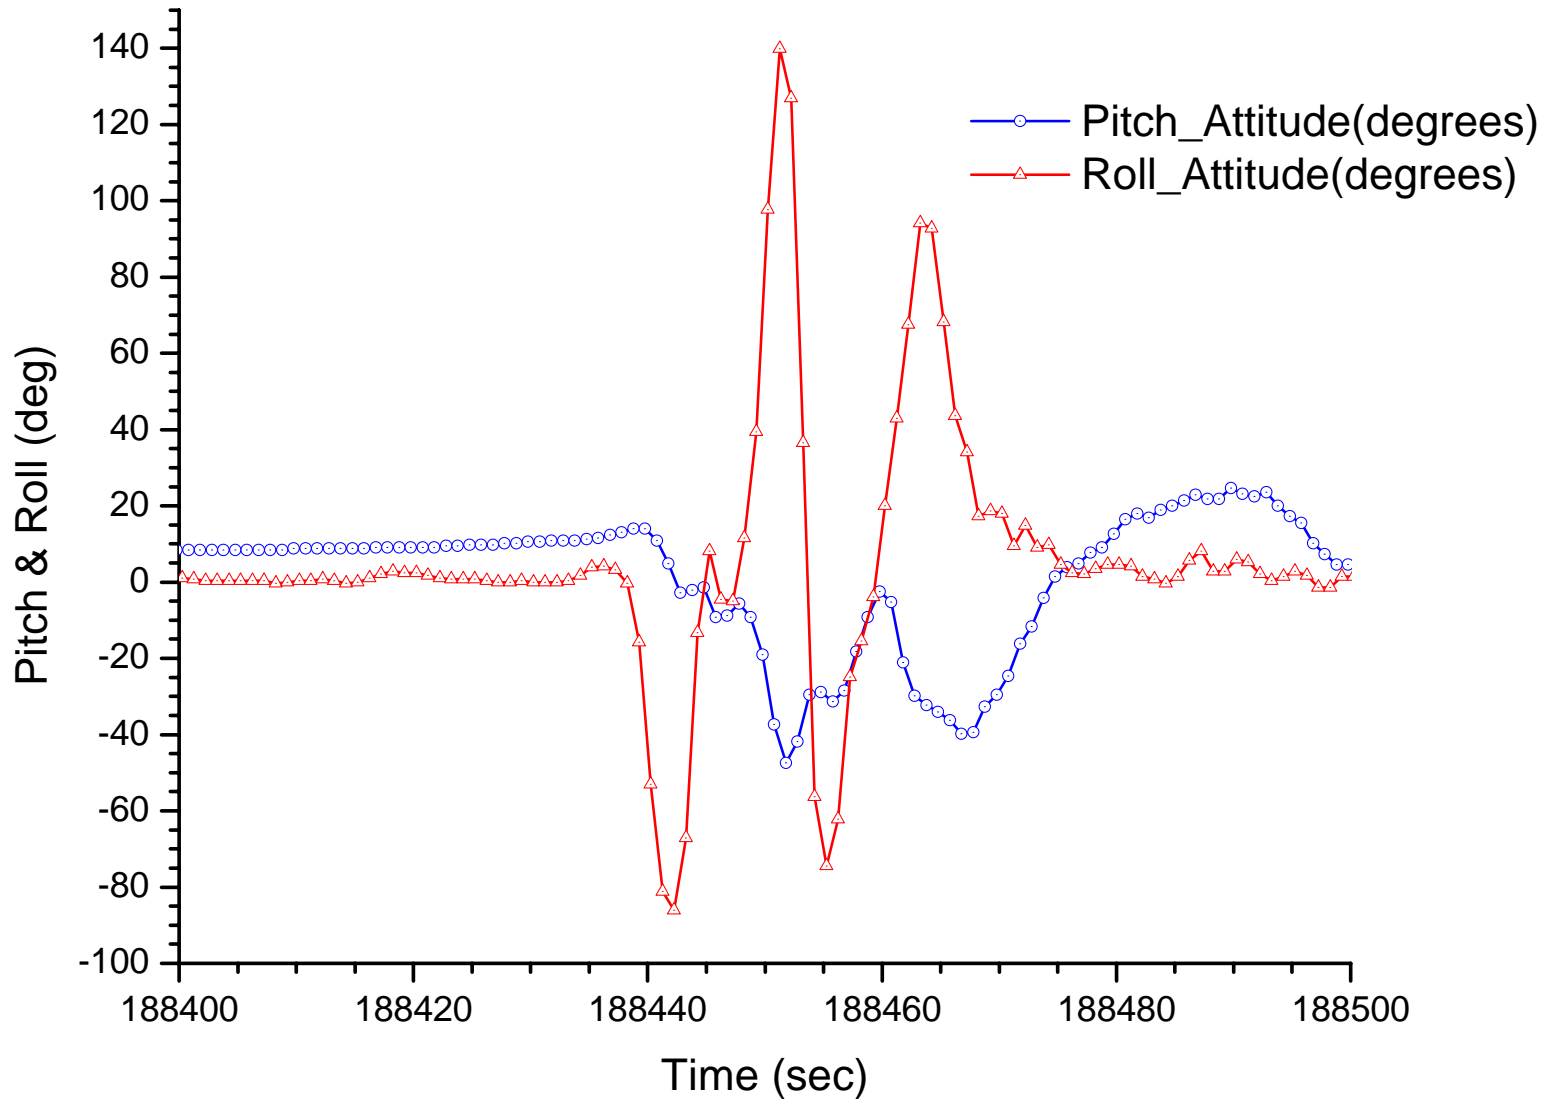
American Eagle SAAB SF-340

- Autopilot engaged during climb
- Aircraft continuously lost speed during last 2.5 minutes before entering stall (>55 kts in 2.5 minutes)
- Aircraft departed controlled flight at an indicated air speed of approximately 126 kts, concurrent with stick shaker
- Aircraft dropped from 11,700 ft-msl to 6500 ft-msl

- Resulted in 4 urgent recommendations
  - Minimum airspeed
  - Modify stall protection
  - Ice detection
  - Disengage autopilot in icing conditions
- FAA working with Saab and EASA to determine response
- FAA issued Safety Alert for Operators
