# Aircraft Break-Up

Tony Cable - AAIB, UK

SAE 2007 Aircraft & Engine Icing International Conference

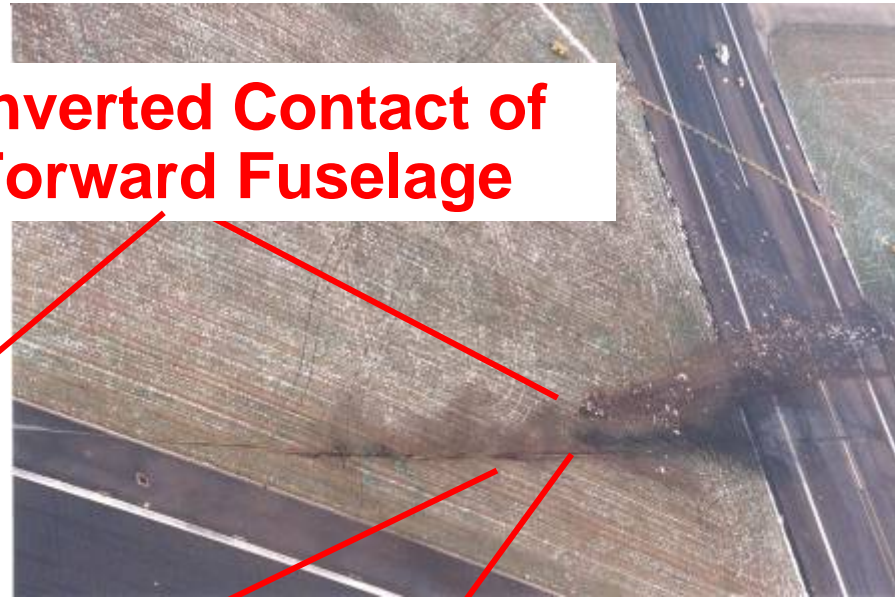
**Inverted Contact of Forward Fuselage**

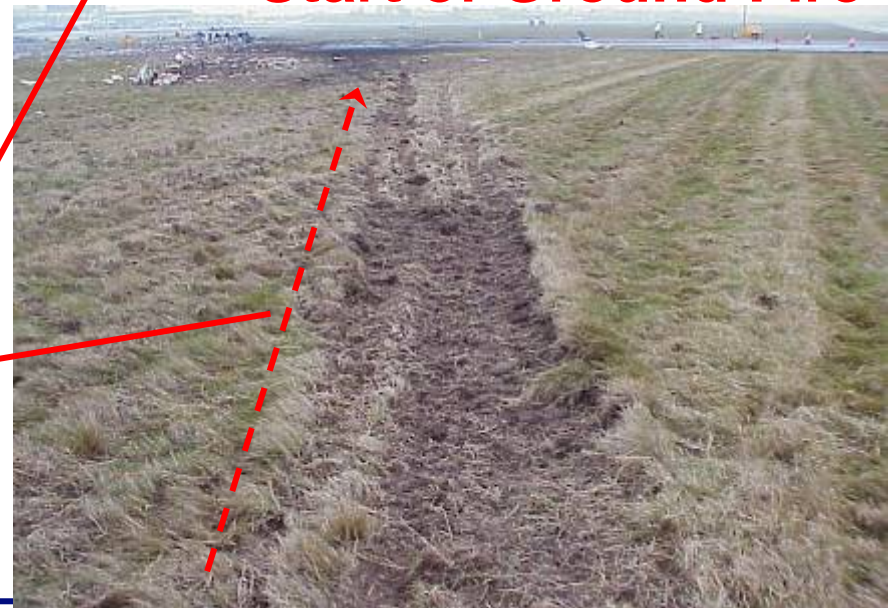
**Start of Ground Fire**

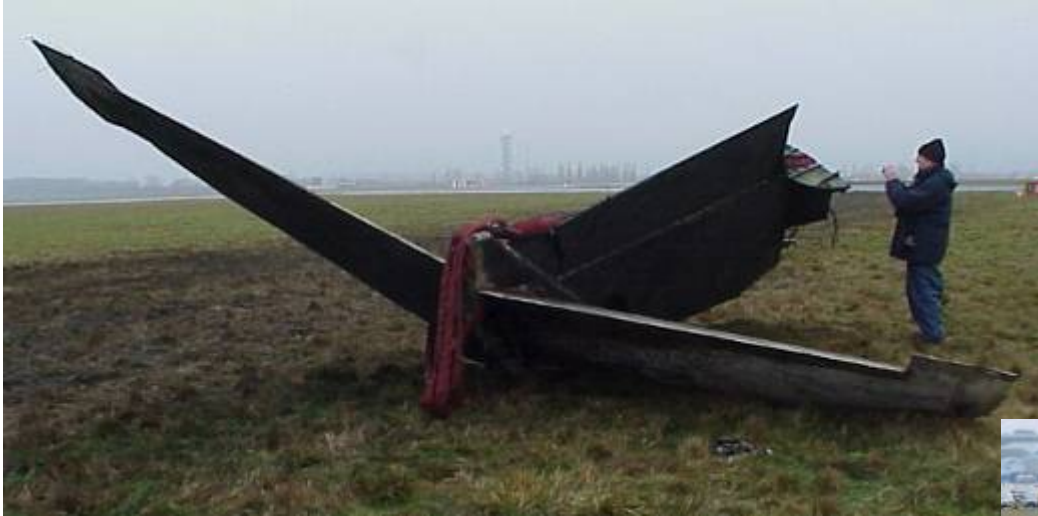
**Continuing break-up of outboard part of Left Wing – Fuel Tank rupture**

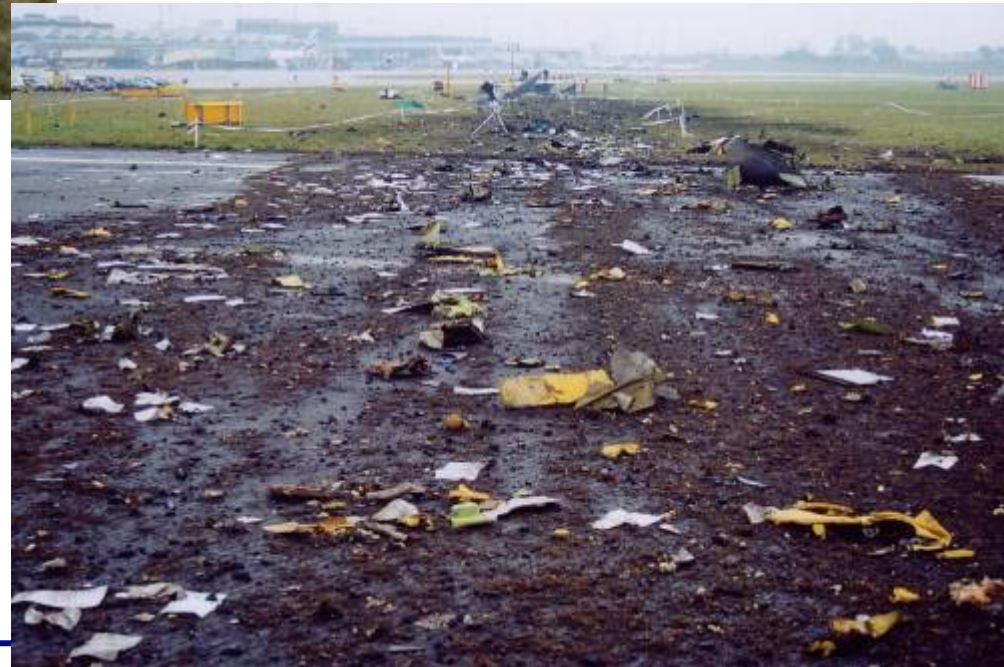
**During inverted  
Ground Slide**

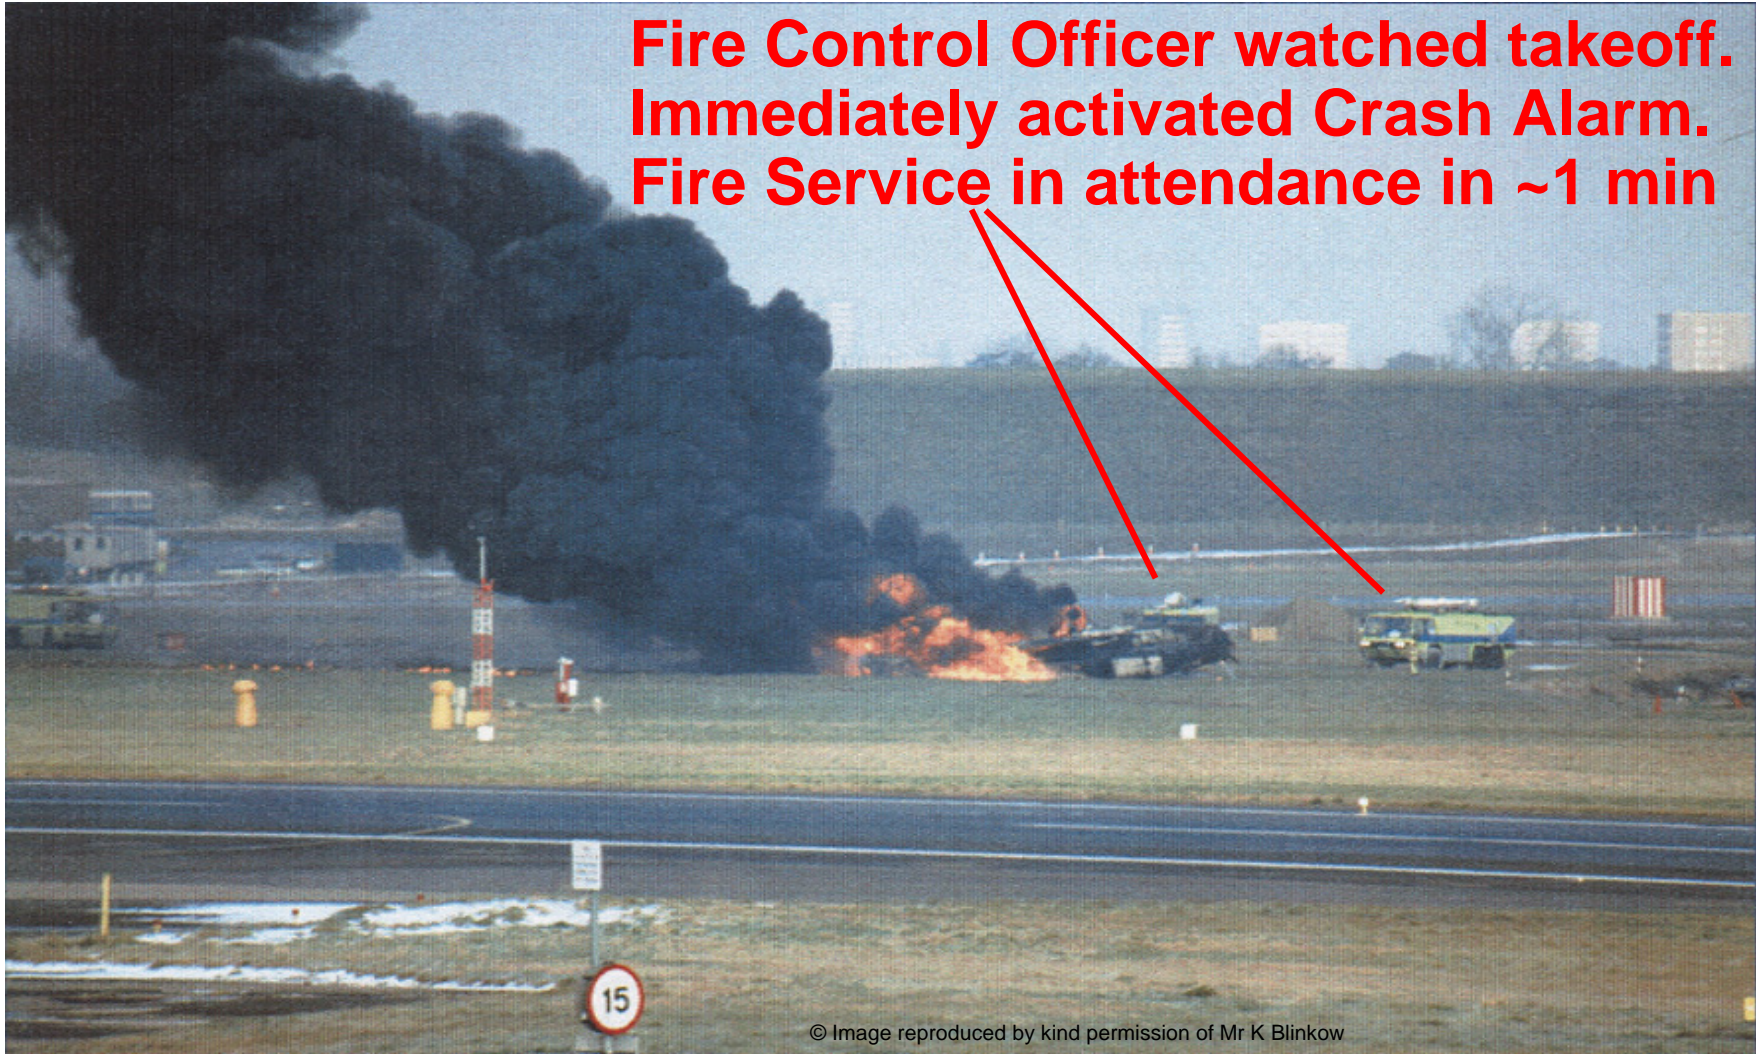
# Ground Fire

**Fire Control Officer watched takeoff. Immediately activated Crash Alarm. Fire Service in attendance in ~1 min**

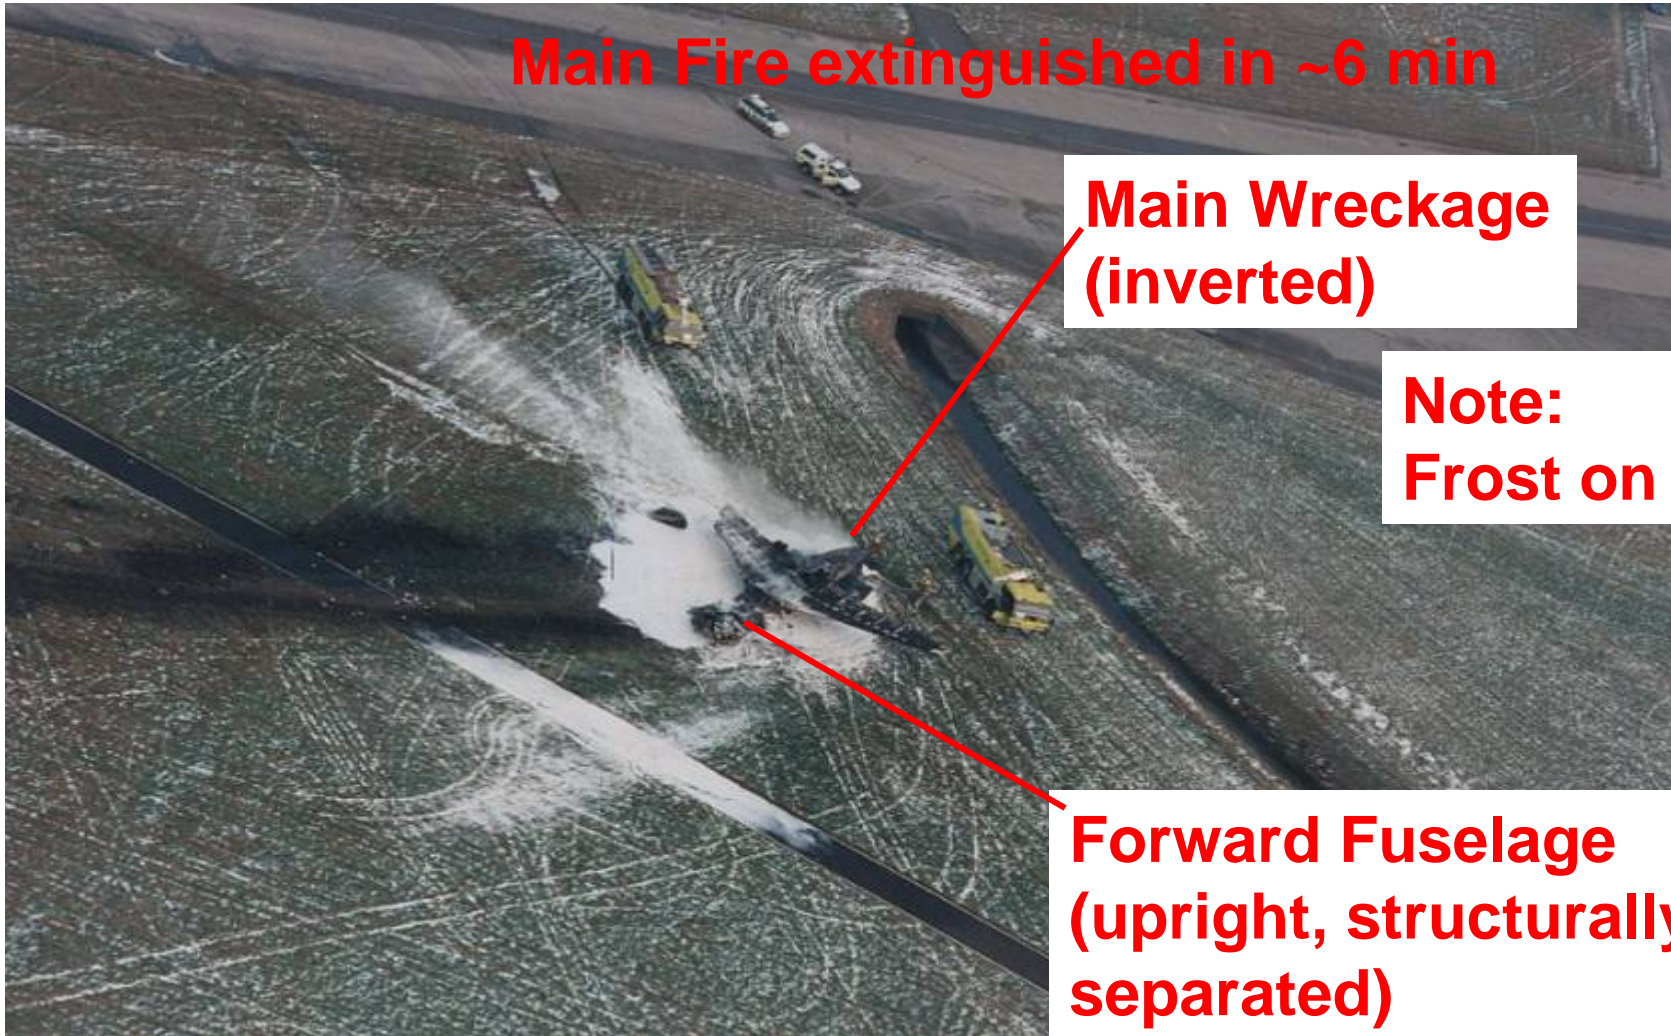
# Main Wreckage

**Main Fire extinguished in ~6 min**

**Main Wreckage  
(inverted)**

**Note:  
Frost on grass**

**Forward Fuselage  
(upright, structurally  
separated)**

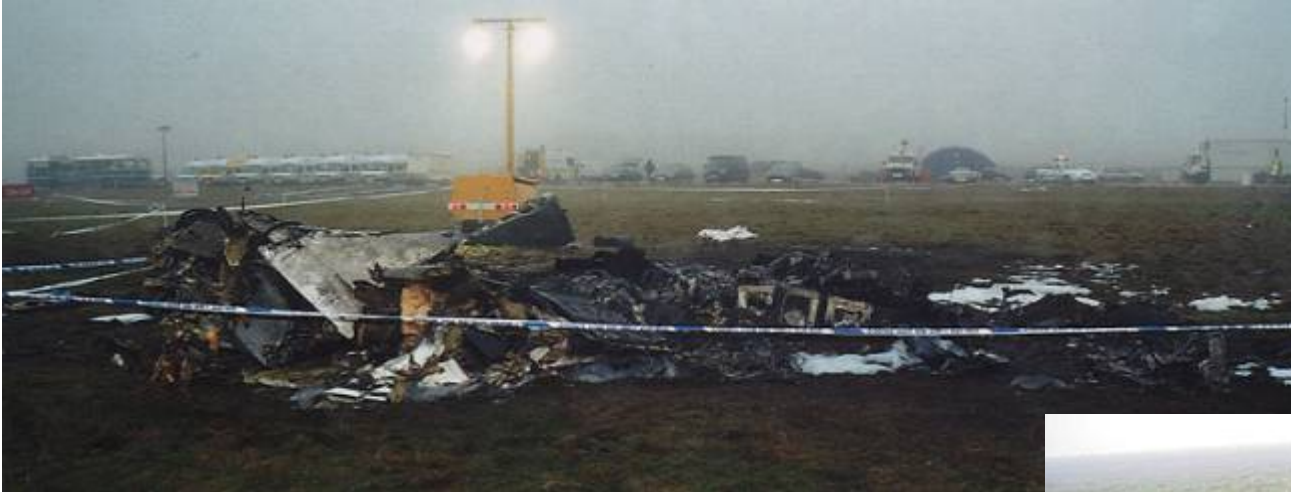
# Ground Fire Damage

**Appreciable fire damage to Forward Fuselage**

**Forward Fuselage**

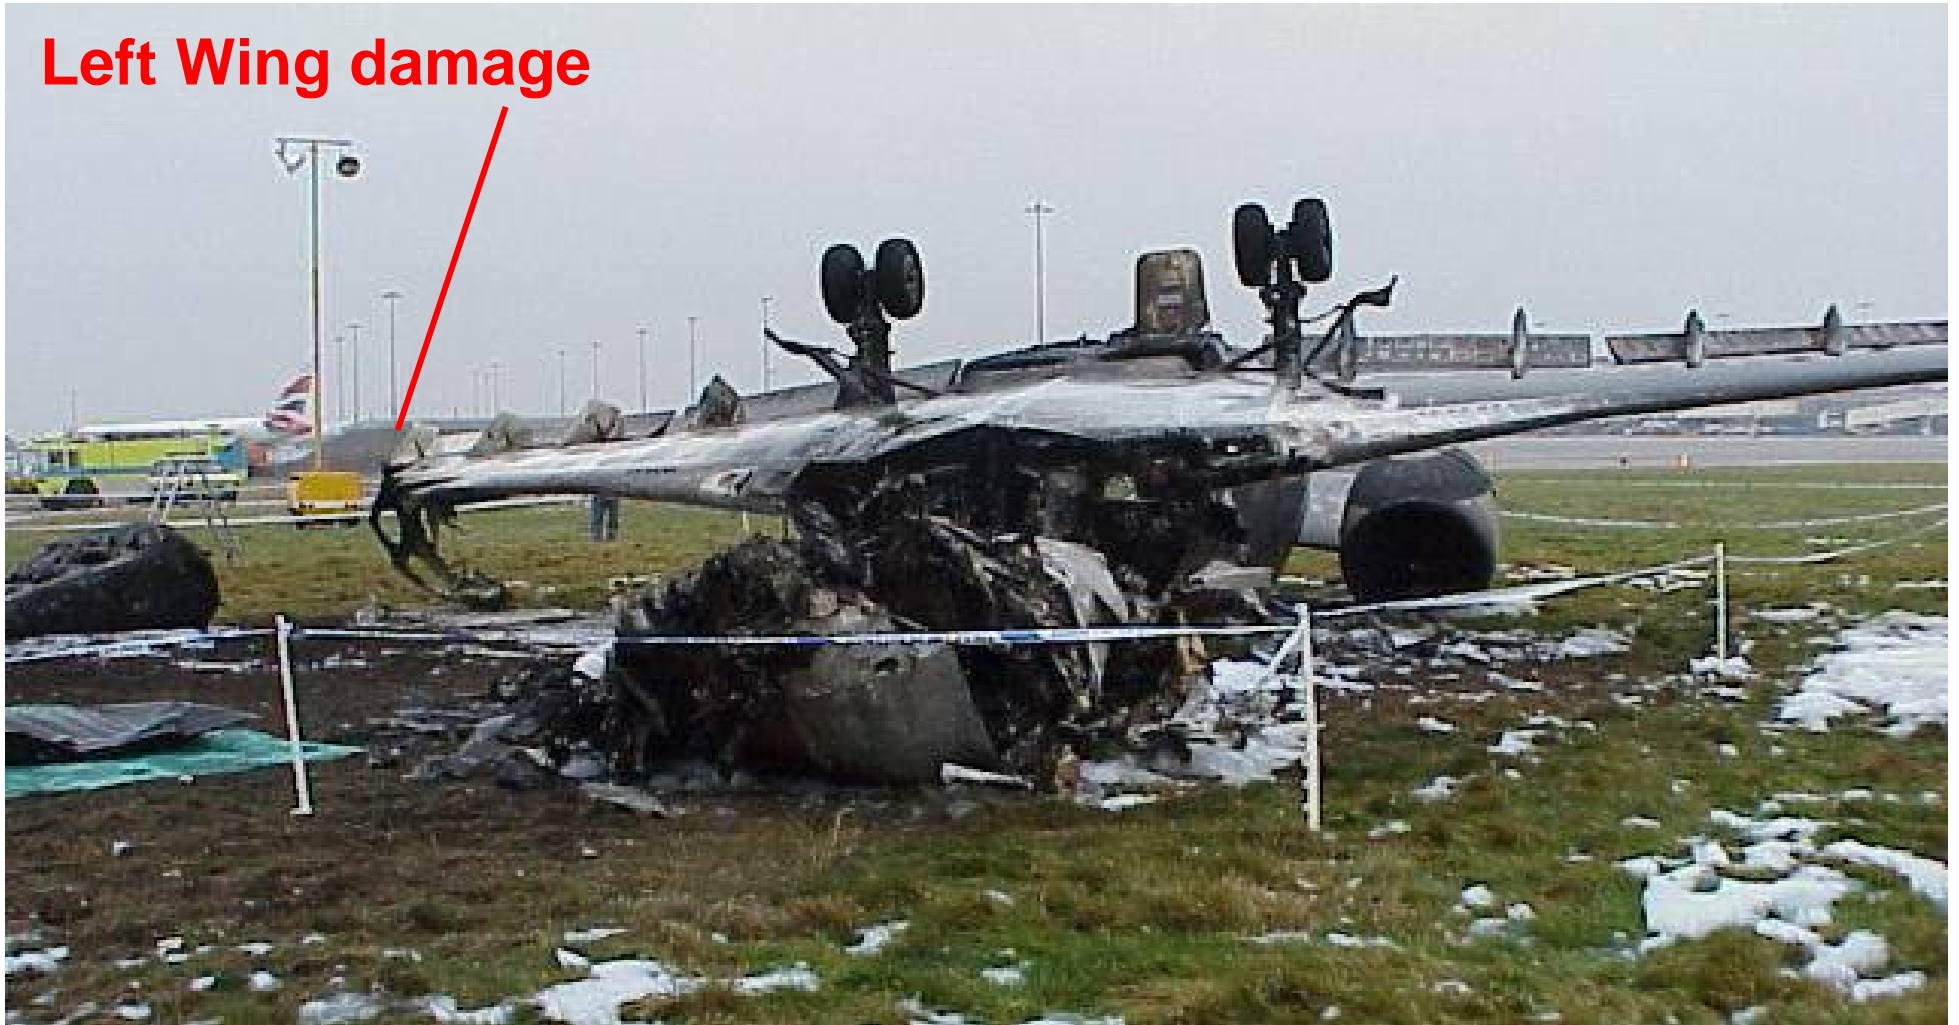
# Main Wreckage

Left Wing damage
