TukLoc as a repair fastener

Great ideas"
competition

October 2004

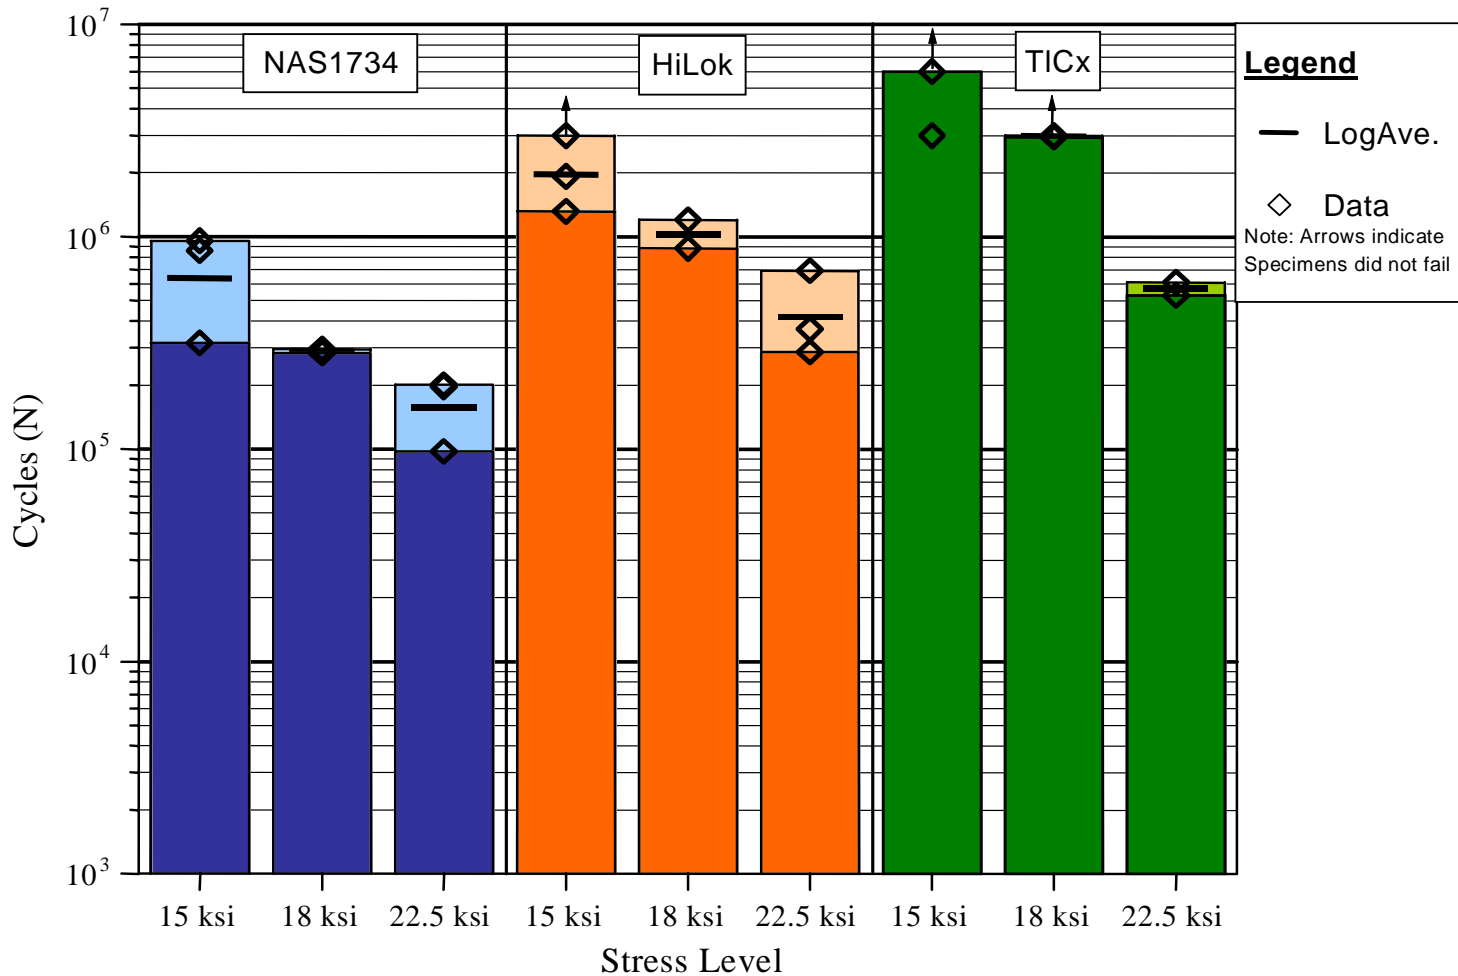
Low Load Transfer Fatigue Test Results

8% Effective load
Transfer dogbone
specimen

Sample installation to assemble two pieces
