TukLoc as a repair fastener

Great ideas”
competition

October 2004

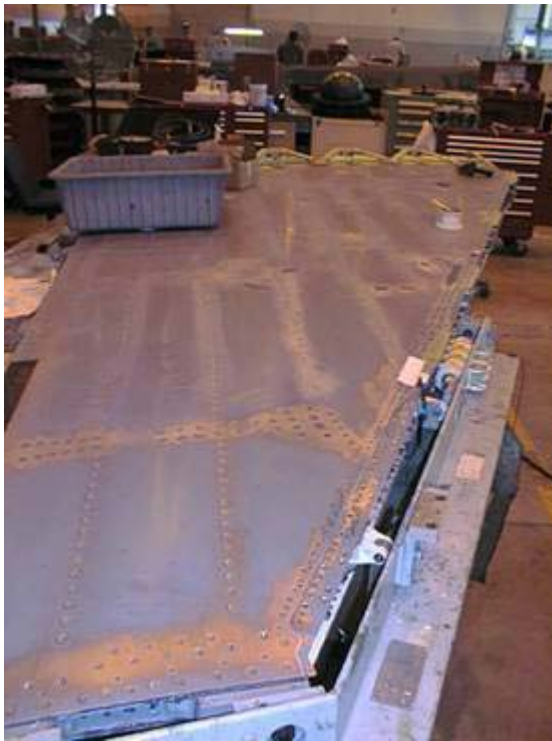
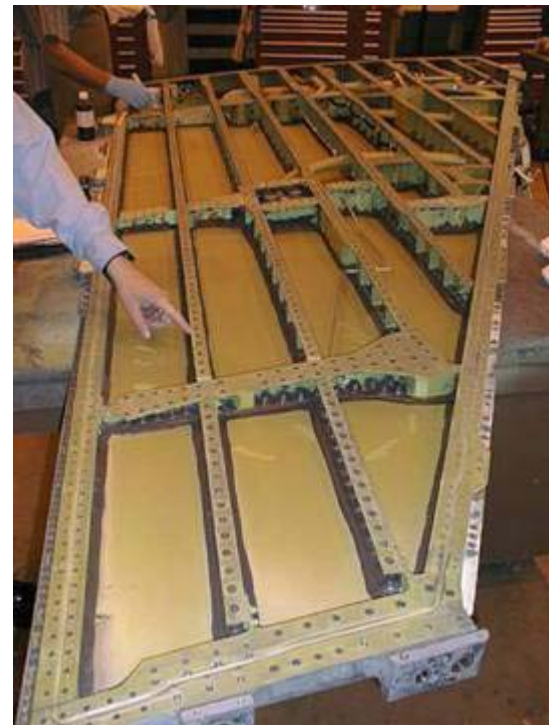
Historical option

- Repairing these skins requires the removal and replacement of the wing skin, a costly and cumbersome repair.

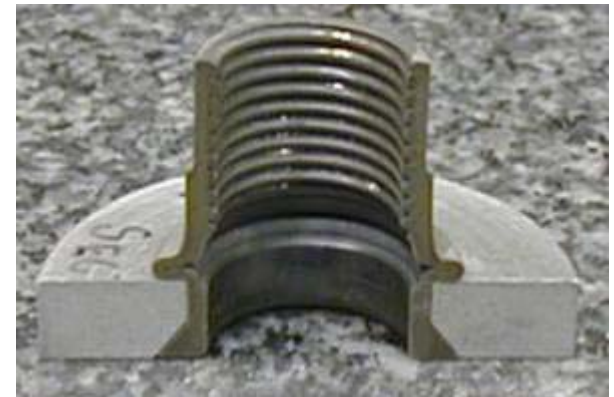
- A new technology has been developed that will remove small cracks (up to 0.035" in length) and reinforce the wing skin without removing the skin.
- This technology can be implemented as a preventative modification before the onset of fatigue cracks.
- This technology can be applied to any metallic or composite structure, especially where traditional maintenance practices are not feasible.

- Interference fit in skin and rib
- Stiffens the joint
- Does not require skin removal
- WAF's will be removed during planned maintenance
- Coldworking is an effective adjunct to the TukLoc installation
- Note the remnants of the old NAS fastener head remain in the hole

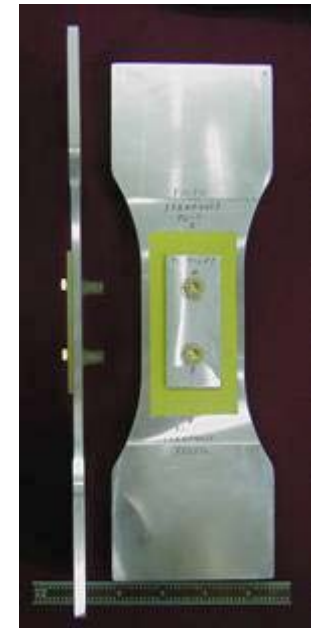
Low Load Transfer Fatigue Test Results

8% Effective load
Transfer dogbone
specimen

Sample installation to assemble two pieces

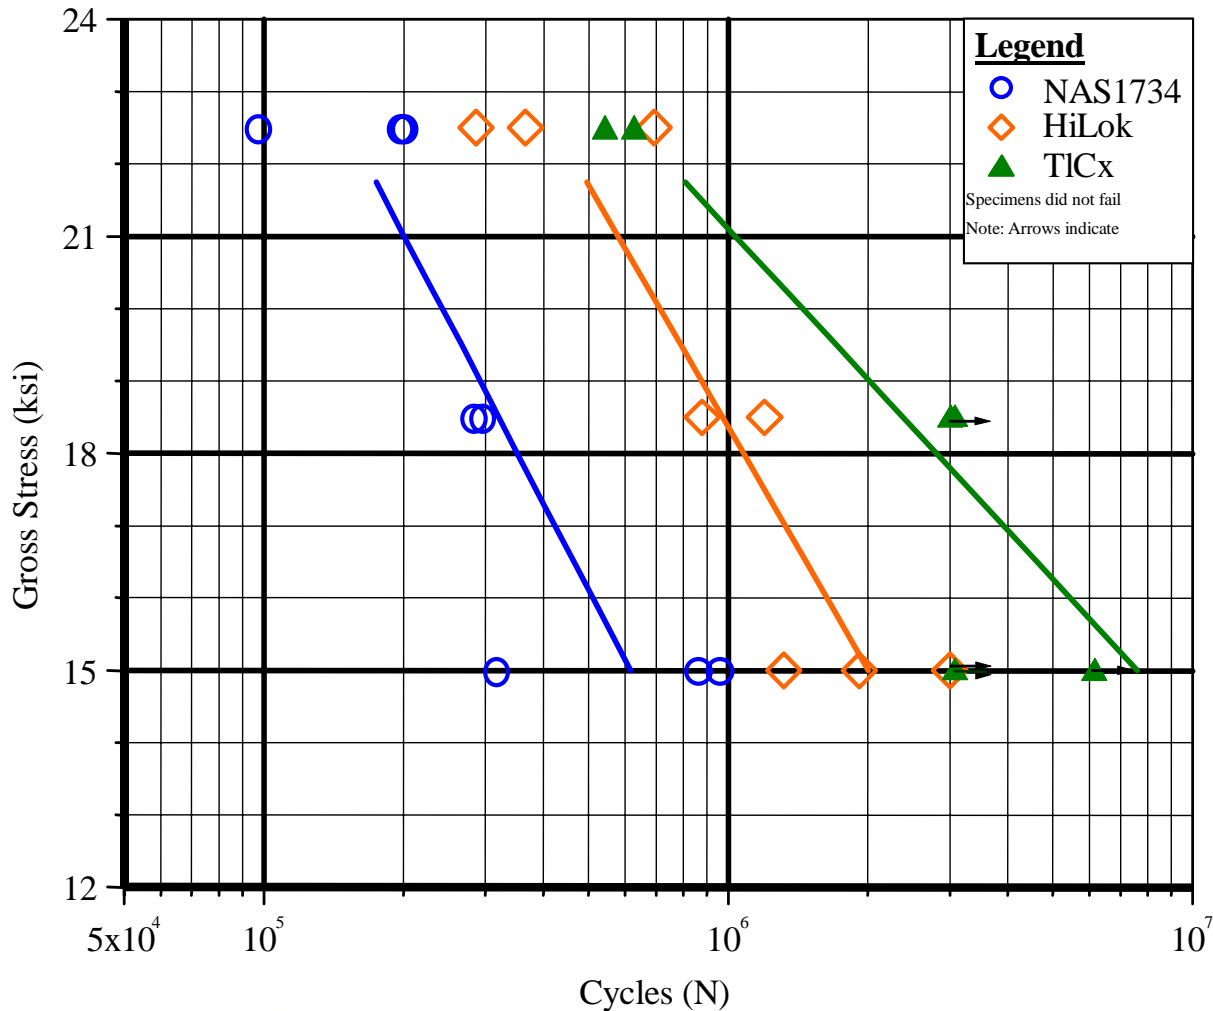
TukLoc™ – S-N Curves

2024-T3 Alum.

- The TukLoc fastener has been tested in fatigue, and finite element models have been created to show the residual stress effects in the skin and rib structure at rest, and under load.

- The combination of the interference fit and compressive residual stresses resulted in a significant life improvement for TukLoc nuts over NAS 1734 nuts at all stress levels
- The compressive stress in the parent material after the installation of a TukLoc nut resulted in life improvement over HiLok fasteners at all stress levels*. This may be contributed to a reduced mean stress and crack closure effects.
- Expanding TukLoc nuts in the wing skin and spar will eliminate the need for skin replacement. This will save the USAF \$\$ millions in the life of the F-16 fighter.

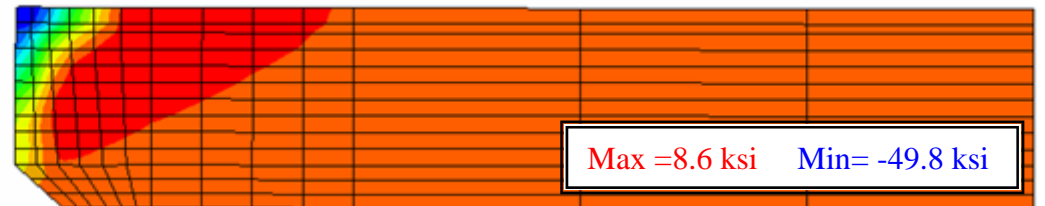
Residual Stress State of Installed TukLoc Nut

Residual hoop stresses are due to expansion of the TukLoc with the mandrel and the collapse of the “bulge”

Hoop compressive stress and interference are higher on the “bulge” side but continue down the majority of the bore

Max = 8.6 ksi Min = -49.8 ksi

A-A

- Lower stress amplitude than NAS 1734 nuts is due to the interference fit at the hole edge
- Lower mean stress than HiLok fasteners due to the residual compressive stresses at the hole edge
- Peak stress was compressive in a significant portion of the bore at the hole edge. Crack retardation would be expected
