# Columbia Accident Investigation Board

## *RCC Forensic Evidence of Breach Location*

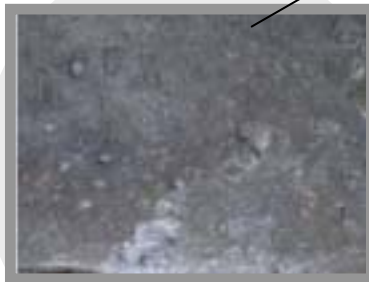
**Heaviest Slag Deposits**

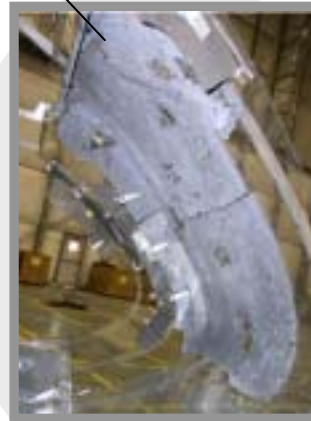
**Void of Metal Components**

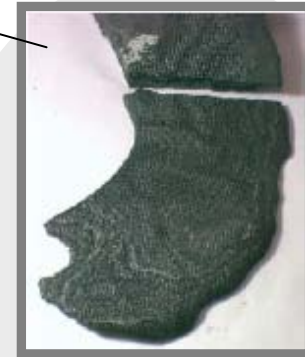
**Knife-Edge Erosion**

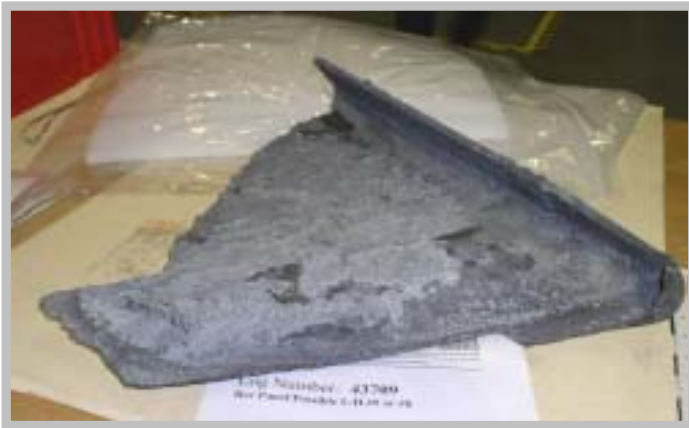
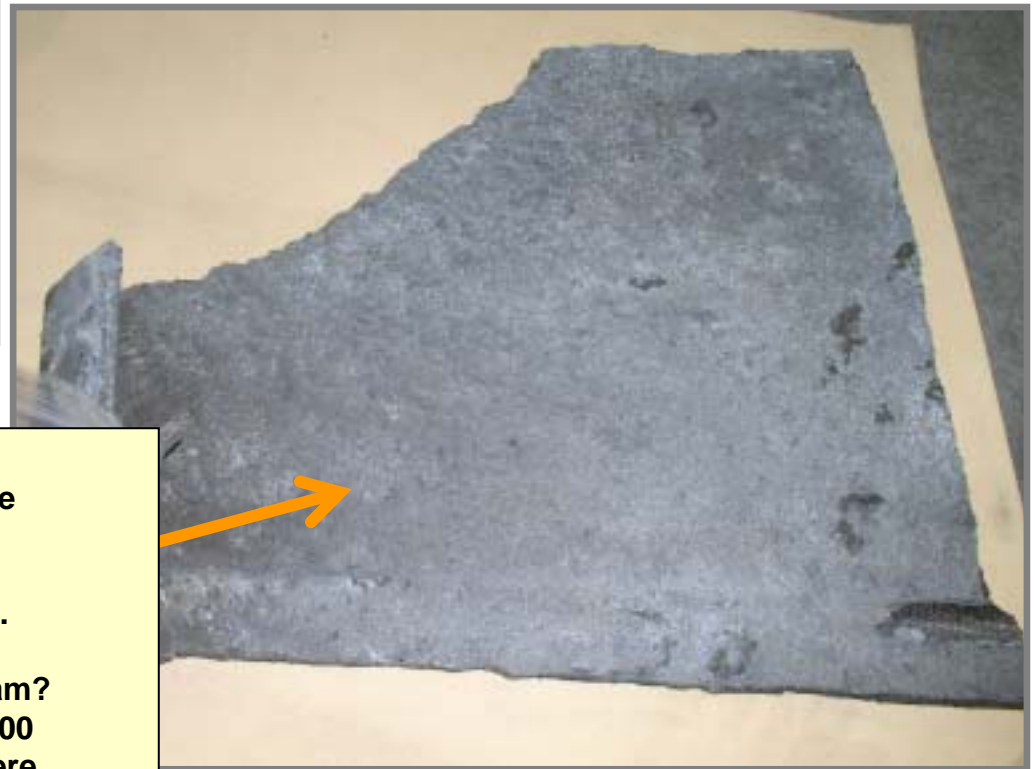
## Deposits on RCC Panel 8

- Volume and composition of deposits indicate prolonged deposition of leading edge construction materials at RCC panels 8 and 9

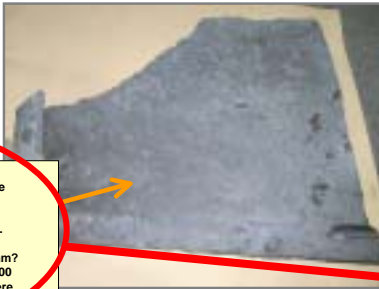
#### Deposits on RCC Panel 8

- Volume and composition of deposits indicate prolonged deposition of leading edge construction materials at RCC panels 8 and 9

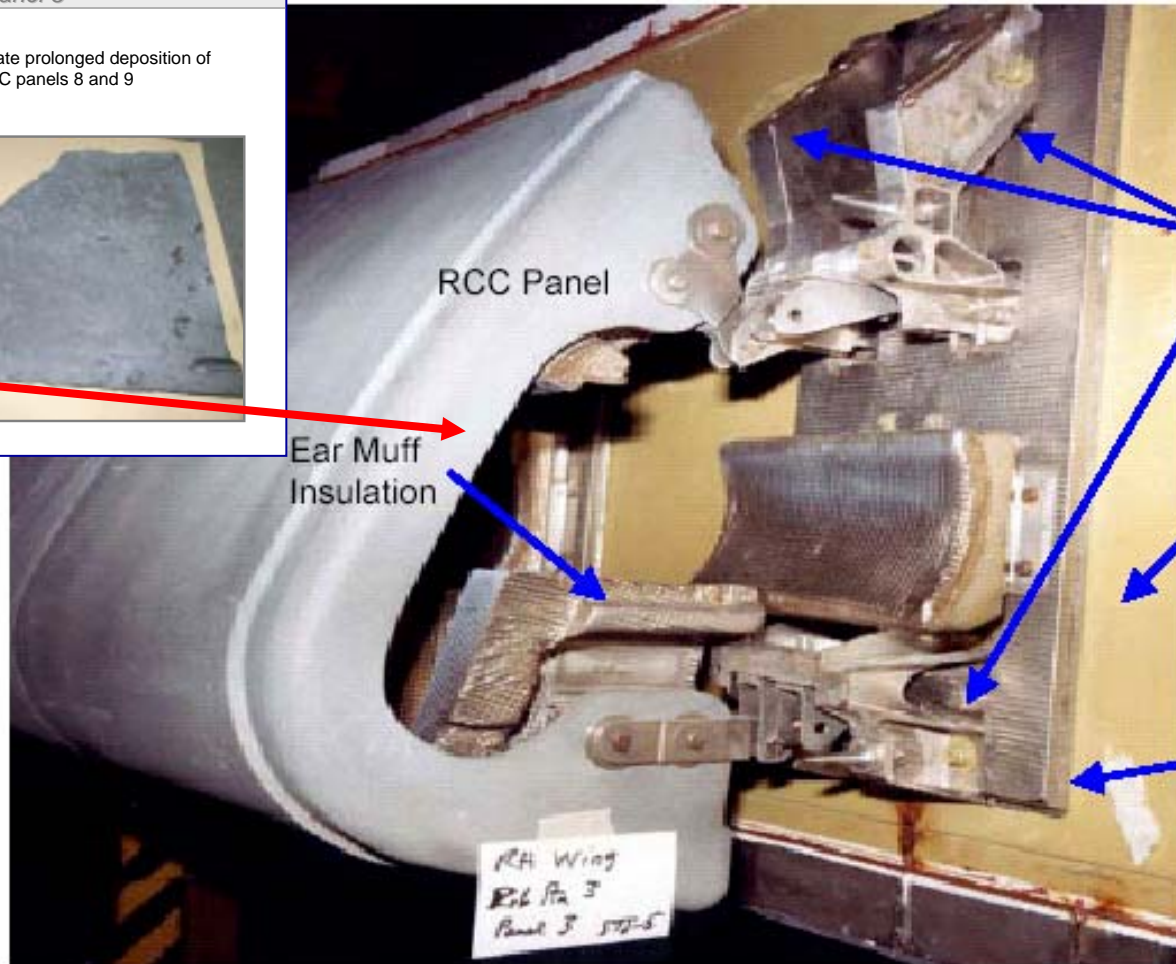
RH Wing  
Rib Sta 3  
Panel 8 575-5

Spar Attach Fittings (4)

Wing Leading Edge Spar

Spar Insulator

RCC Panel

Ear Muff Insulation

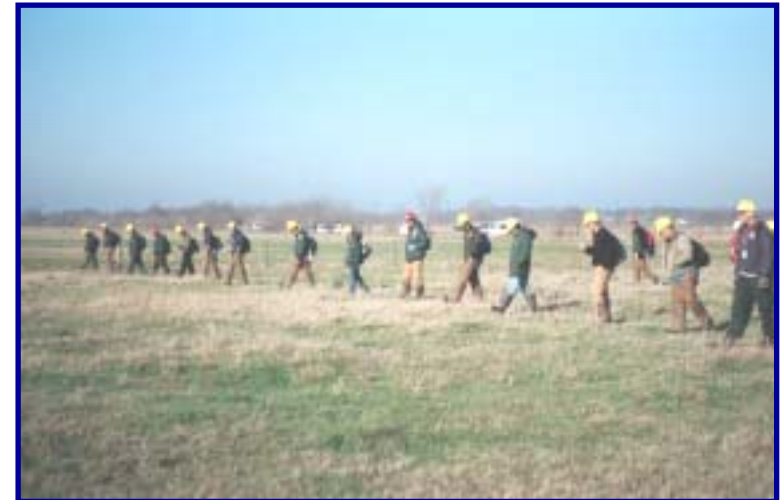
- **Final Reconstruction Statistics:**

- **~40%** of *Columbia* was recovered
- **84,900** pounds of material
- **84,000** parts processed at KSC
