# **The Continuing Threat to Aviation Safety from Aircraft Icing**

**A Review of Recent NTSB Accident and Incident Investigations**

Daniel R. Bower, Ph.D.

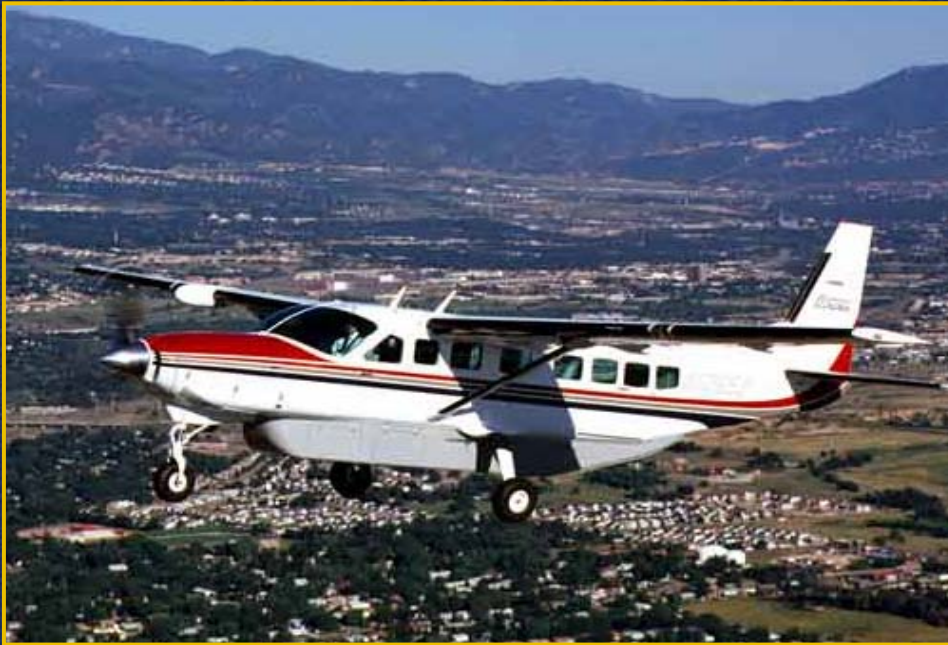
# Cessna 208B Caravan

- Single-engine turboprop airplane
- Several icing-related fatal accidents in recent years

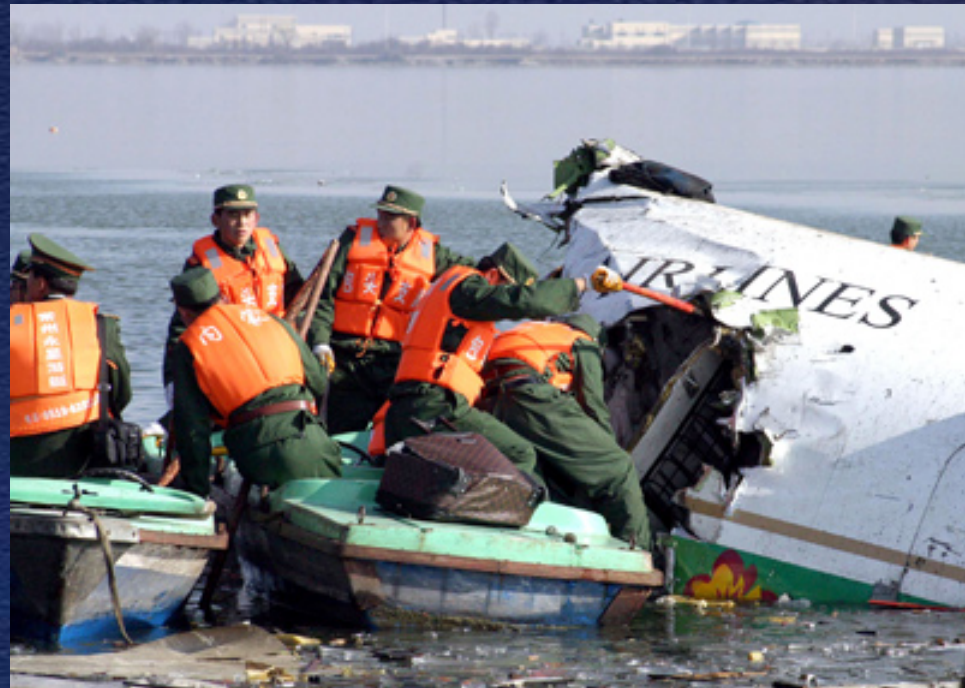
# Baotou, China - China Eastern Airlines November 21, 2004

- CRJ 200 impacted lake shortly after takeoff
- 53 fatalities on aircraft
- Two fatalities on ground

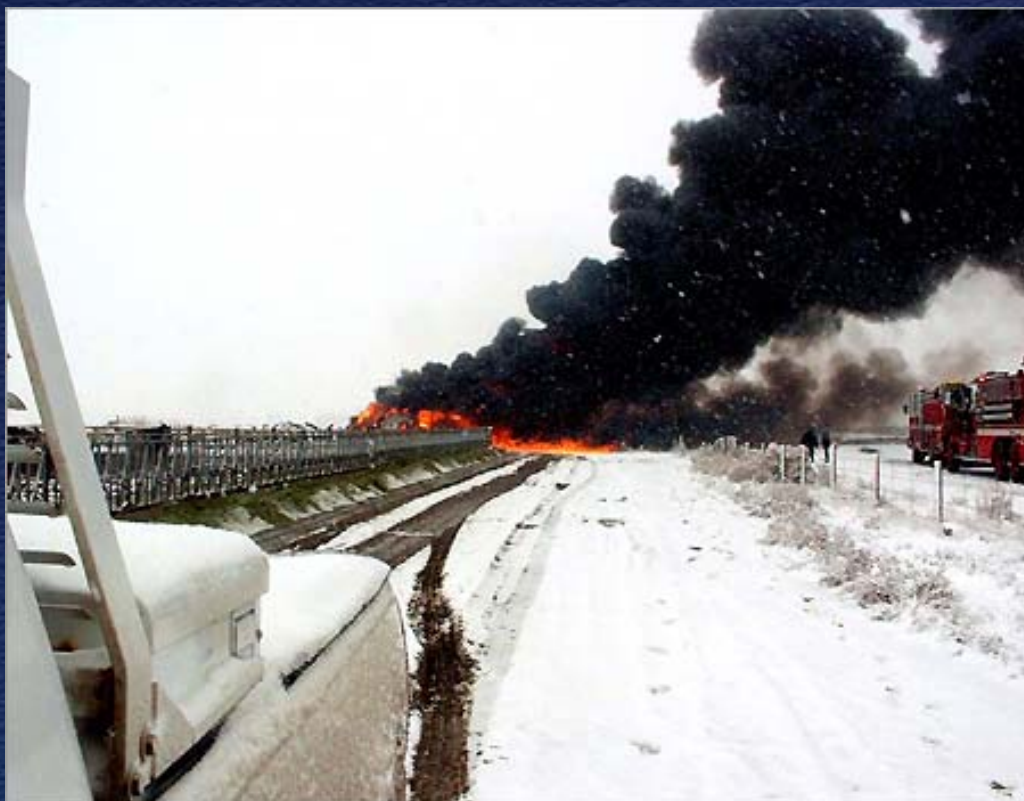
Montrose, CO – November 29, 2004

- 3 fatalities, 3 seriously injured
- Crashed during takeoff

“The flight crew's failure to ensure that the airplane's wings were free of ice or snow contamination that accumulated while the airplane was on the ground, which resulted in an attempted takeoff with upper wing contamination that induced the subsequent stall and collision with the ground...”

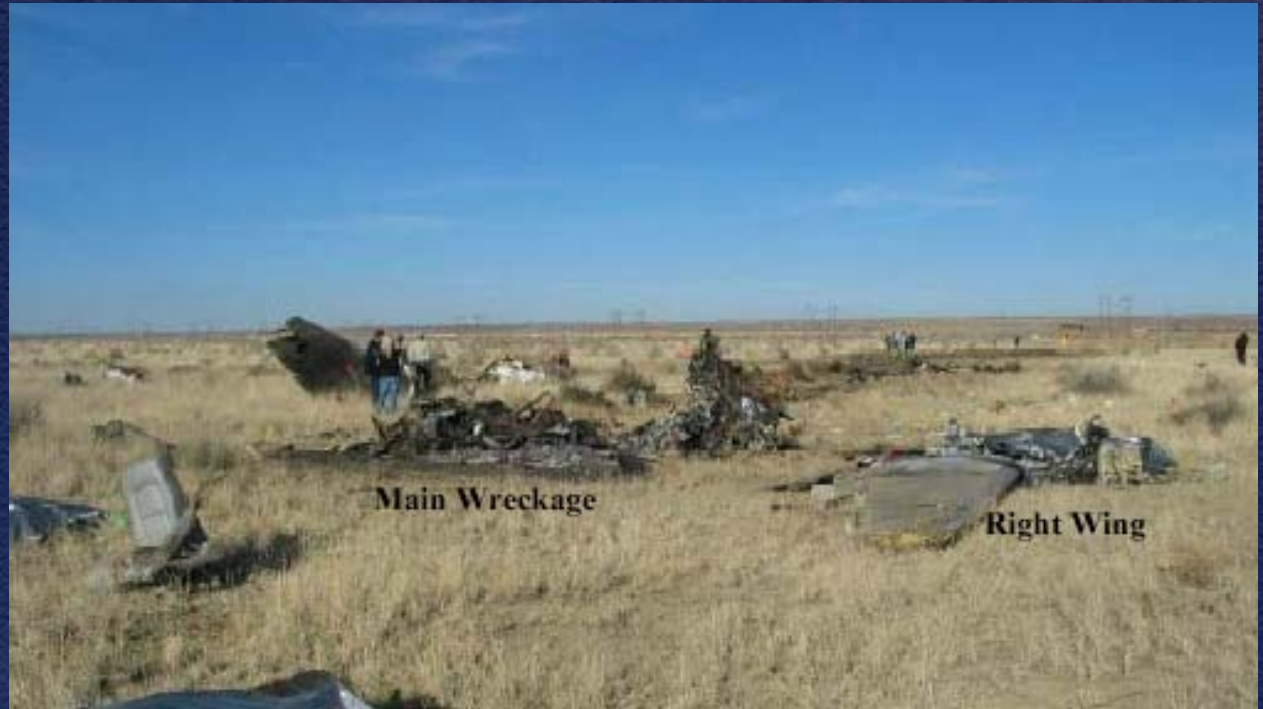
Pueblo, CO – February 16, 2005

- 8 fatalities
- Crashed on approach
- Atmospheric conditions conducive to icing

- Airplane slowed below  $V_{approach}$
- De-ice boots not operated in second icing layer
- Presence of estimated 1/6 inch or less of ice accreted in SLD conditions caused airplane to stall prior to stick shaker
- Airplane entered a rapid left roll prior to stall warning
- Airplane did not recover in the 1,500 feet agl available

“The flight crew’s failure to effectively monitor and maintain airspeed and comply with procedures for deice boot activation on the approach, which caused an aerodynamic stall from which they did not recover...”

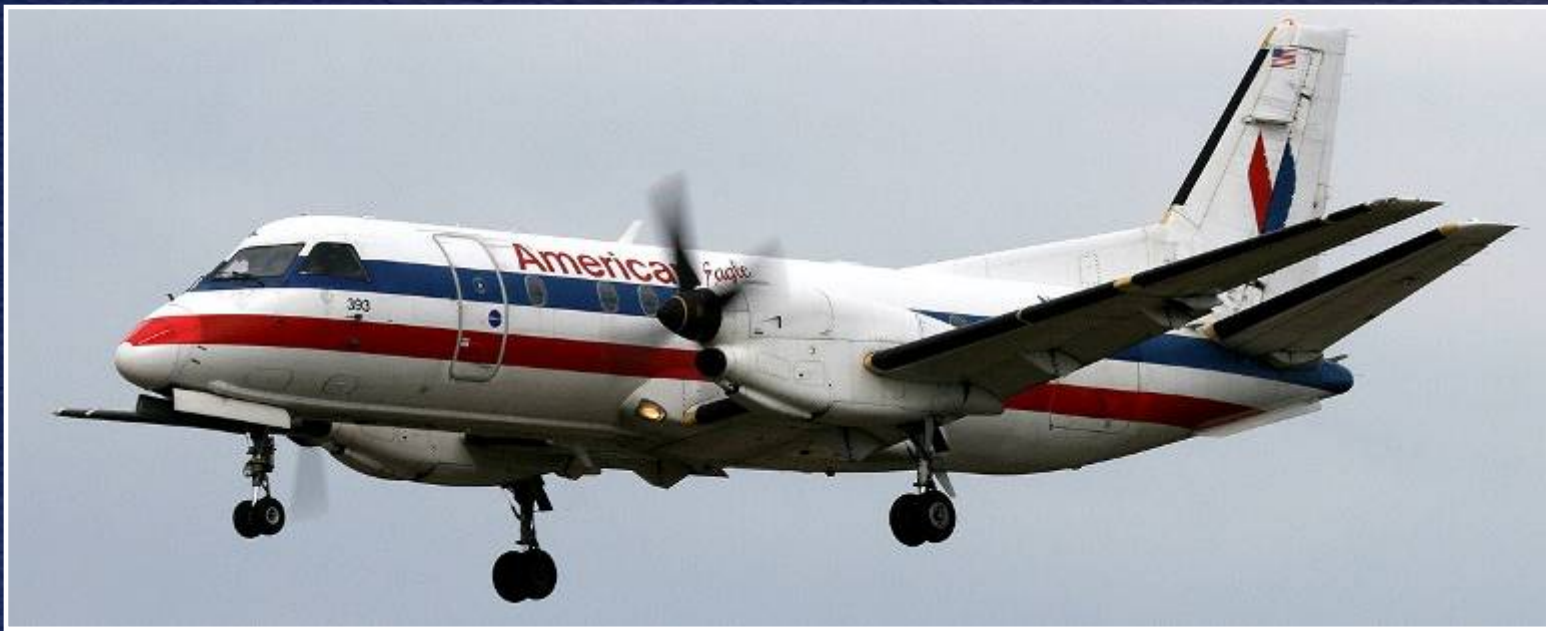
American Eagle flight 3008 – January 2, 2006

- Loss of Control Incident
  - Departed controlled flight in icing conditions
  - Lost 5000 feet altitude
  - Nearly inverted

- Resulted in 4 urgent recommendations
  - Minimum airspeed
  - Modify stall protection
  - Ice detection
  - Disengage autopilot in icing conditions
- FAA working with Saab and EASA to determine response
- FAA issued Safety Alert for Operators
