# Aircraft Break-Up

Tony Cable - AAIB, UK

SAE 2007 Aircraft & Engine Icing International Conference

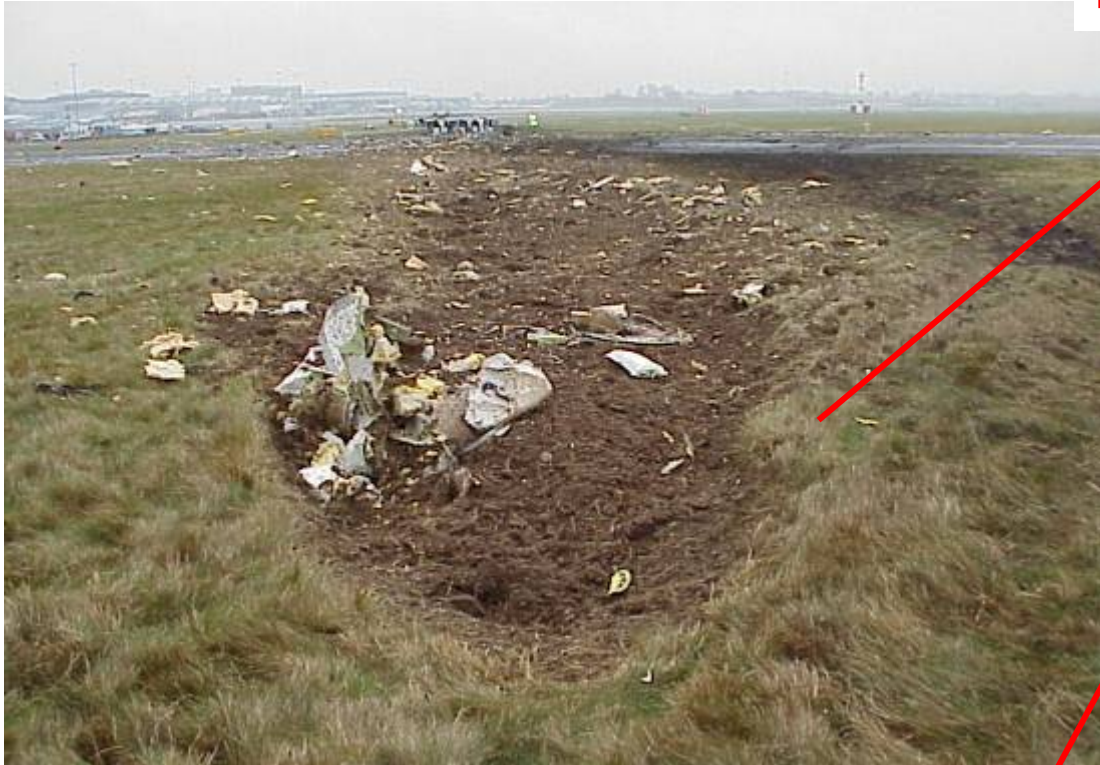
**Inverted Contact of Forward Fuselage**

**Start of Ground Fire**

**Continuing break-up of outboard part of Left Wing – Fuel Tank rupture**

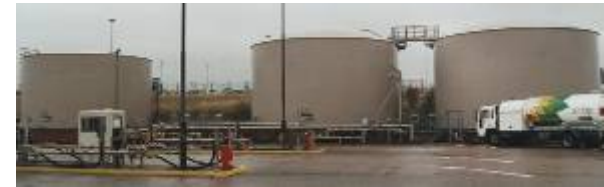
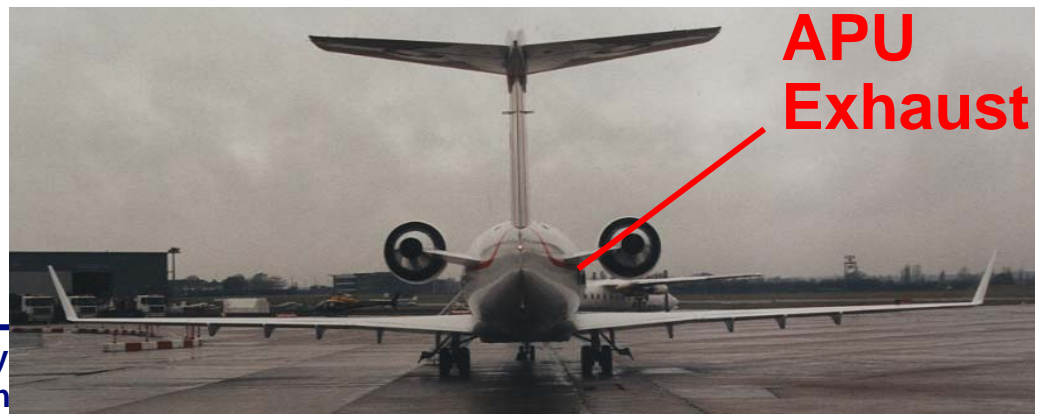
# Icing

- Lots of circumstantial evidence pointing at icing, but:
  - No direct wreckage evidence of airframe ice at takeoff.
- Reported wing frost seen could have been affected by:
  - Solar radiation.
  - Fuel in wing tanks (melting or re-freezing).
  - Engine exhaust gas flows.
  - APU exhaust gas flow.
  - Crash effects:
    - Shock loading.
    - Ground fire.
    - Fire extinguishing.

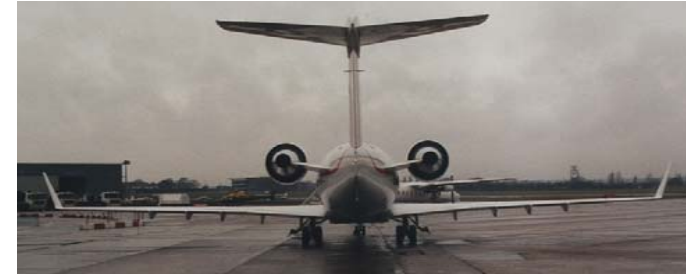
# APU Effects

- With the aircraft parked in a tail wind:
  - The APU exhaust gas would drift forwards over the right wing.
  - Aircraft ground testing showed, after 1 hour APU running:

Wing Station	Mean Temperature Increase - °C	
	Left Wing	Right Wing
Root	1	2
1/3 Semi-Span	1	3
2/3 Semi-Span	1	5
Tip	3	8

- *ie* minor effect on left wing, major effect on right wing.
