2009 SAE Government/Industry Meeting

NHTSA's Rollover Data Special Study (RODSS) Methodology

**Crash Investigation Division
Special Crash Investigations**

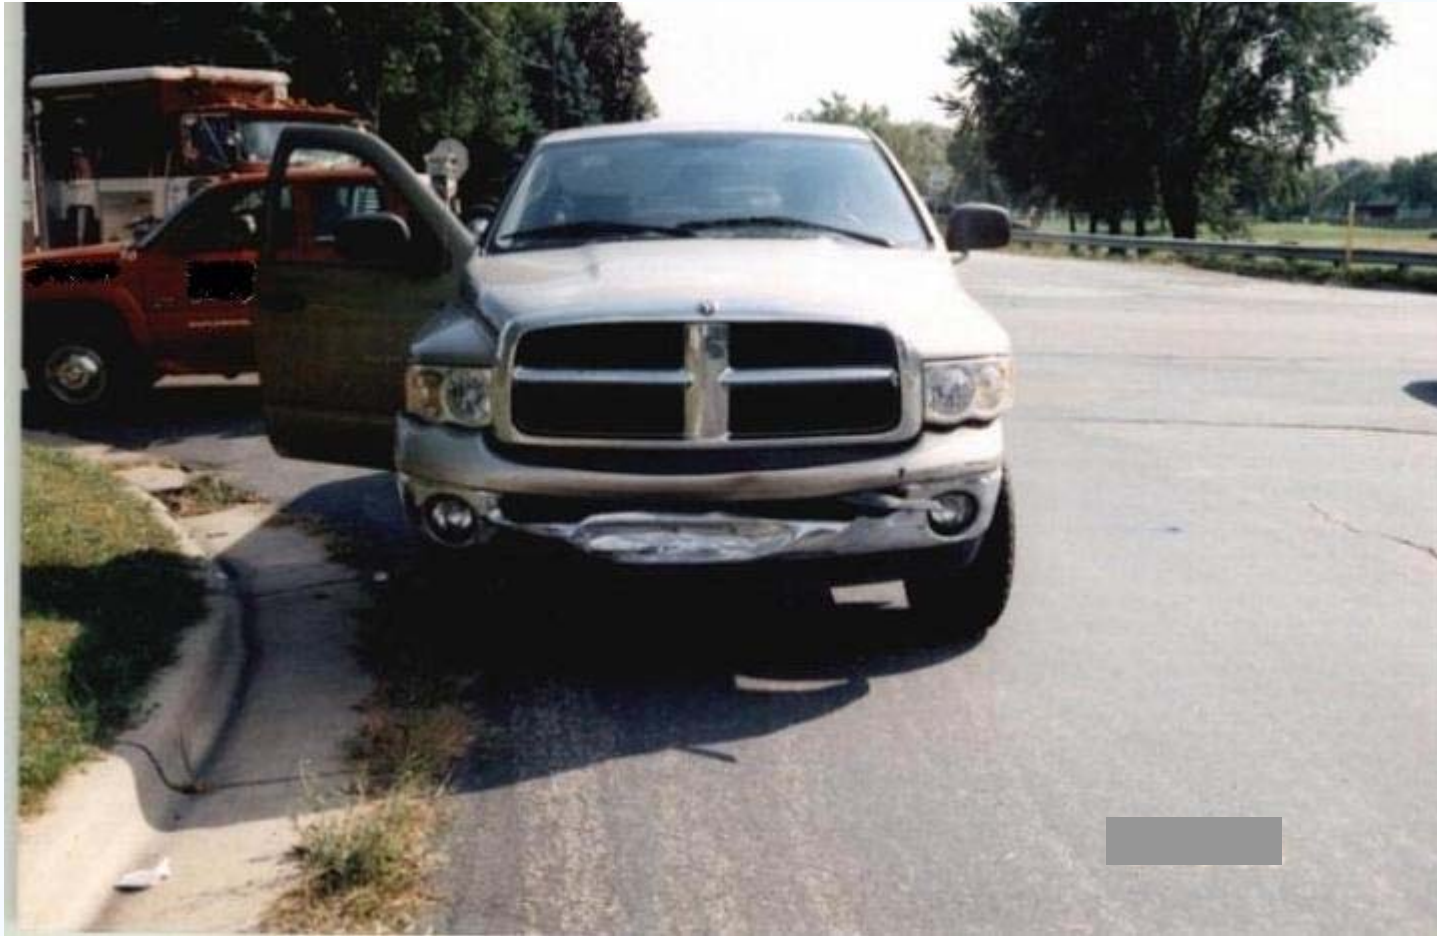
Other Vehicle – 2003 Dodge Ram Quad-Cab

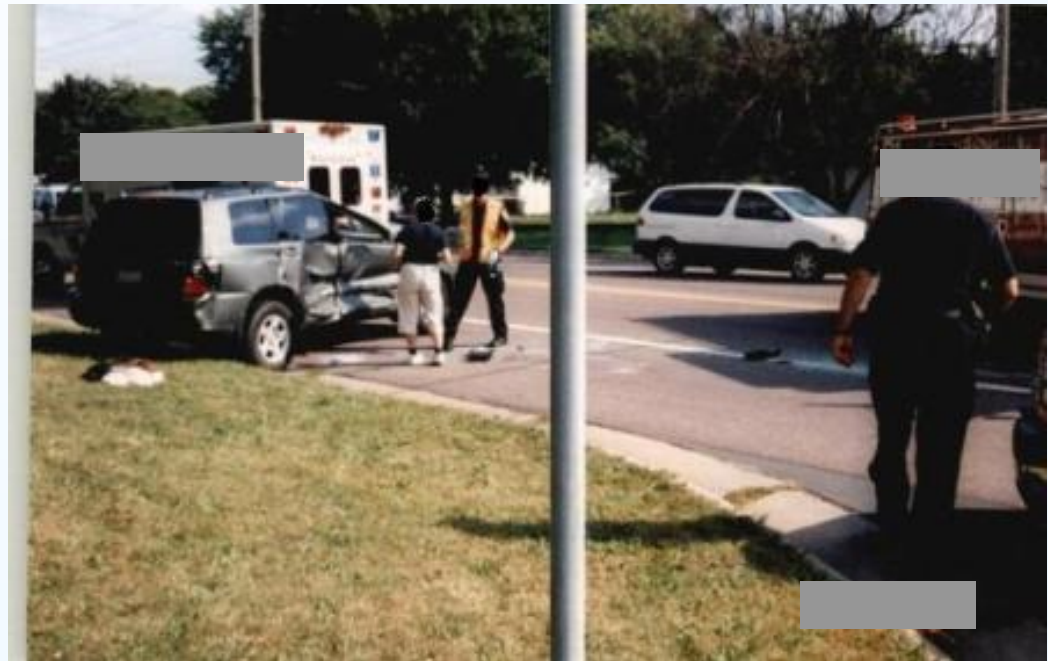
- **Driver – Belted 66-year old female, not injured**
- **Right Front Passenger – Belted 92-year old female, fatal (body area not specified)**
- **Unknown if partially ejected during rollover**
- **RF glazing disintegrated**
