2009 SAE Government/Industry Meeting

NHTSA's Rollover Data Special Study (RODSS) Methodology

**Crash Investigation Division
Special Crash Investigations**

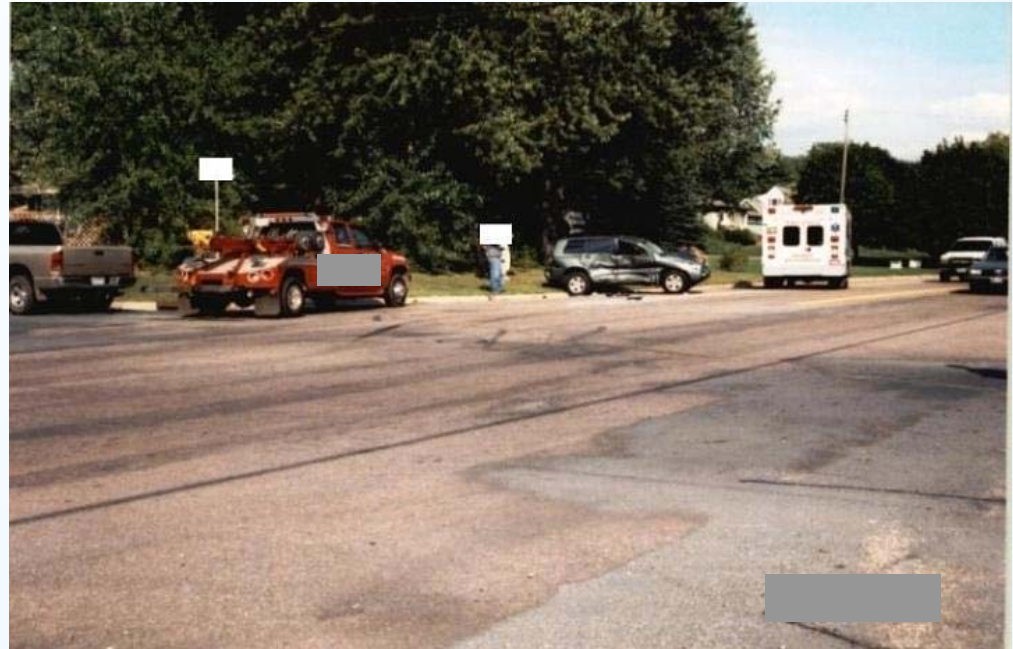
- **Case Vehicle – 2005
Toyota Highlander SUV**
- **ESC – Standard**
- **Inflatable Curtains –
optional, not equipped
on this vehicle**
- **Side Impact Air Bags –
Optional, not equipped**
- **Intersection crash
w/rollover**

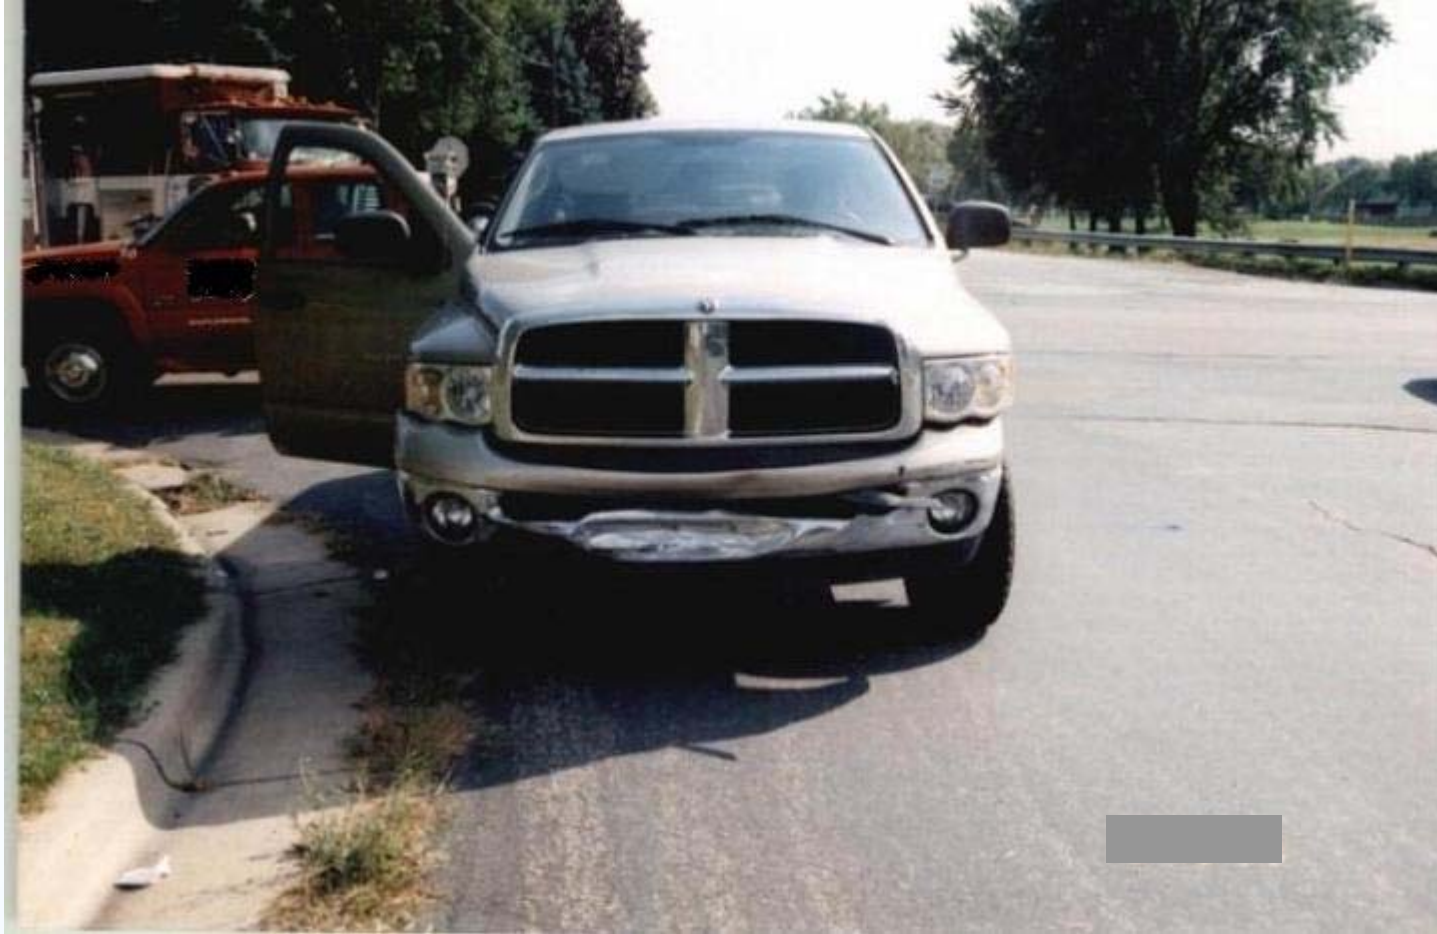
Other Vehicle – 2003 Dodge Ram Quad-Cab

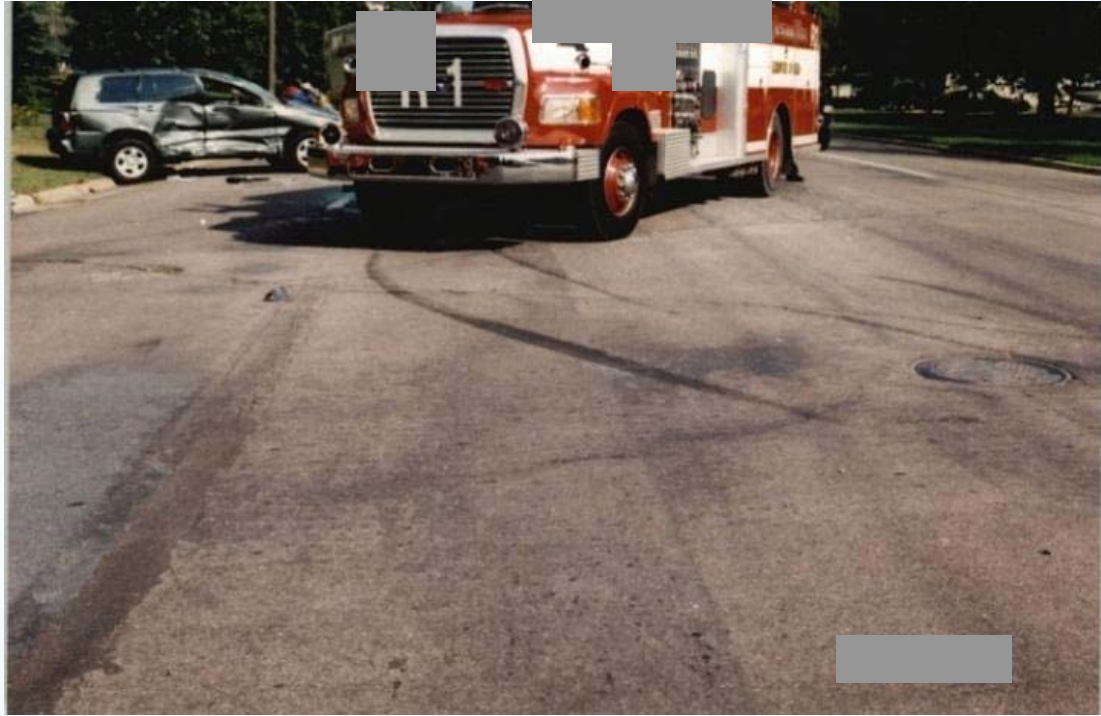
- **Toyota struck on right side,
02RYEW3**
- **Side impact crash induced a CW rotation across intersection**
- **Left side leading rollover**
- **Toyota completed four quarter turns**

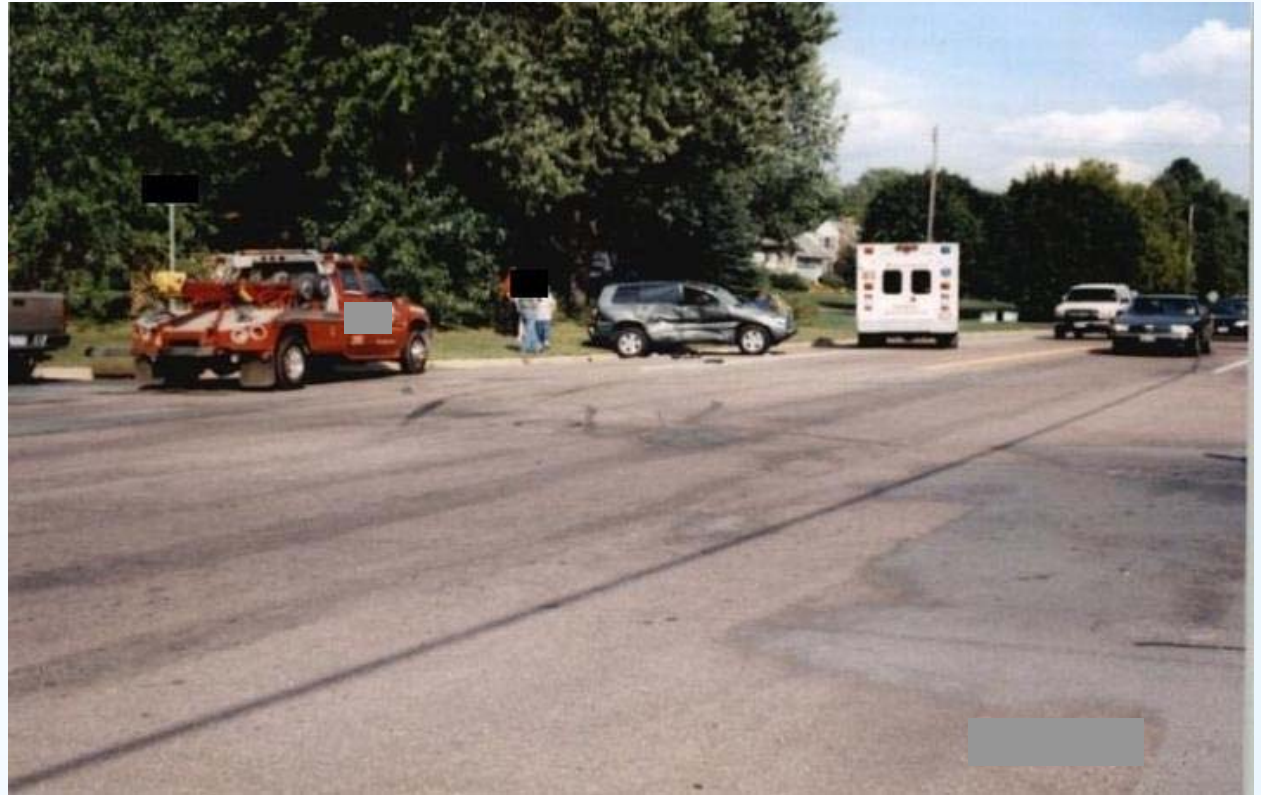
- **Based on the available evidence and the rapid CW rotation, Rollover Initiation was classified as a Turn Over**

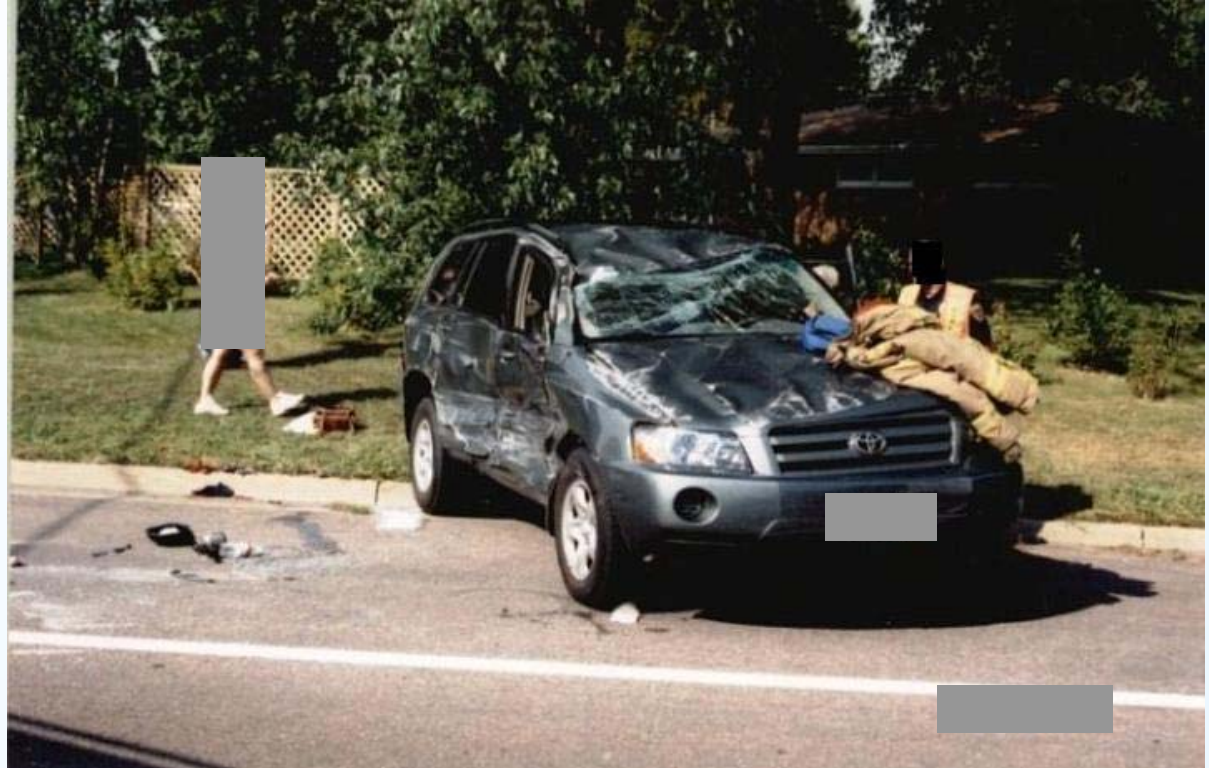
**Toyota Roof Crush
Vertical – Est. at 5”
Lateral - Est. at 2”**

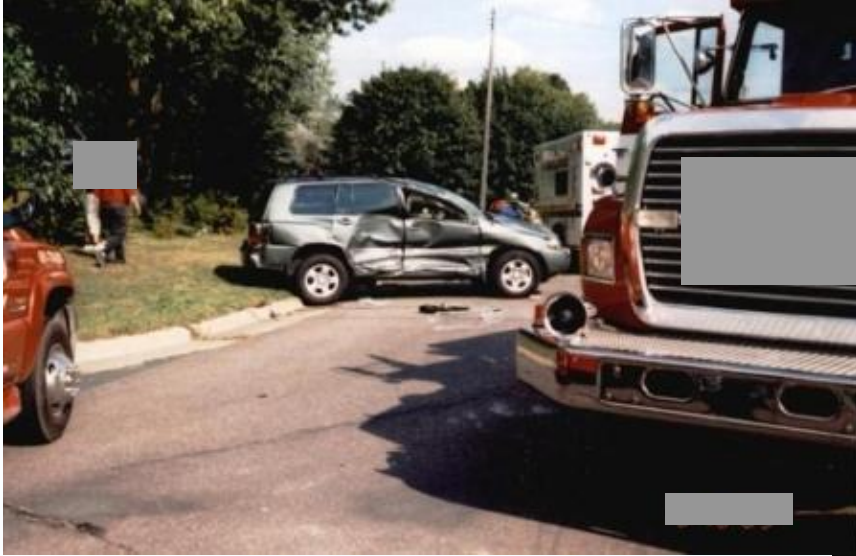
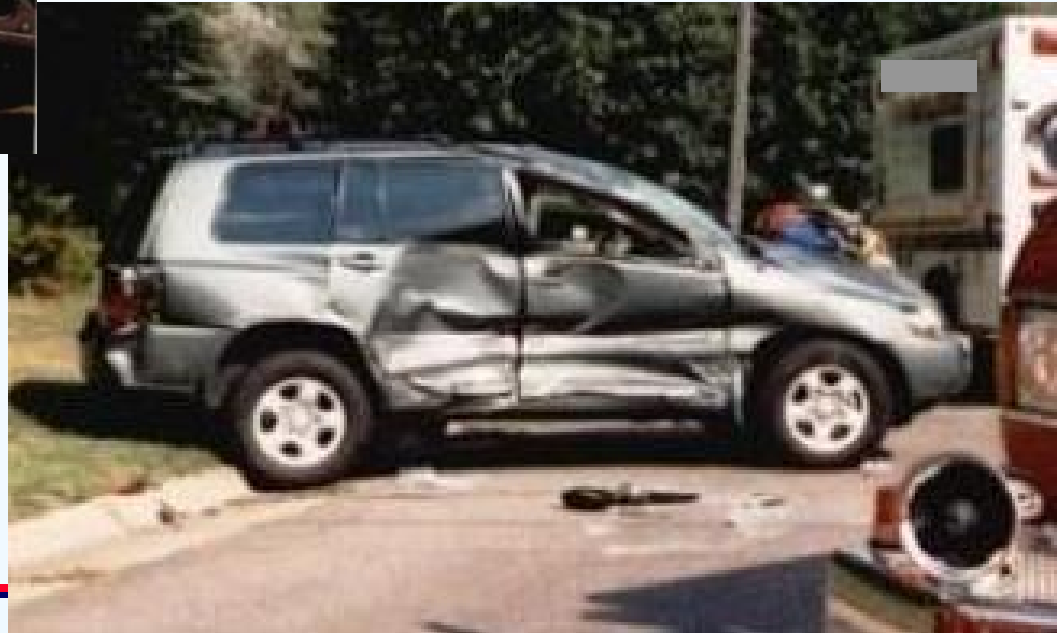
- **Advantage of digital images – ability to zoom for detail**

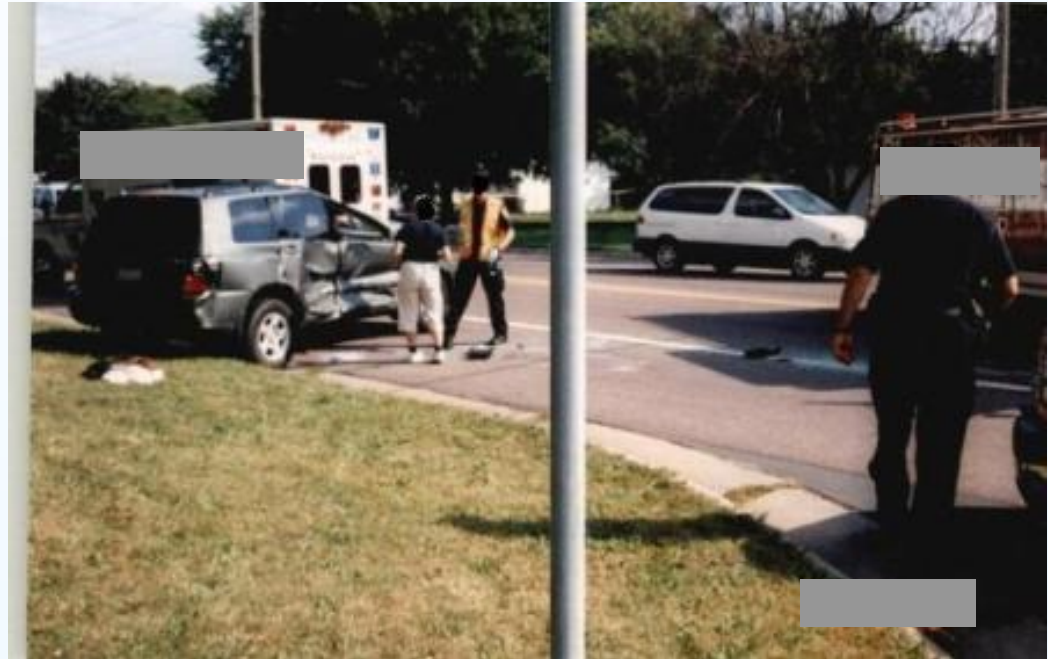
- **Driver – Belted 66-year old female, not injured**
- **Right Front Passenger – Belted 92-year old female, fatal (body area not specified)**
- **Unknown if partially ejected during rollover**
- **RF glazing disintegrated**
